# Access Compliance Report

## Public Rights-of-Way

### (Curb Ramps)

Intersection ID: 10042418	Main Street: YANCEY_RD	Cross Street: N/A	Location: S
ADA ID: 799EBCA38A63	Ramp Type: Para	Initial Pass/Fail: Fail	Overall Compliance: No
		Severity Score: 12.5	
Codes/Mitigation Info/Possible Solution		Field Measurements/Component Compliance

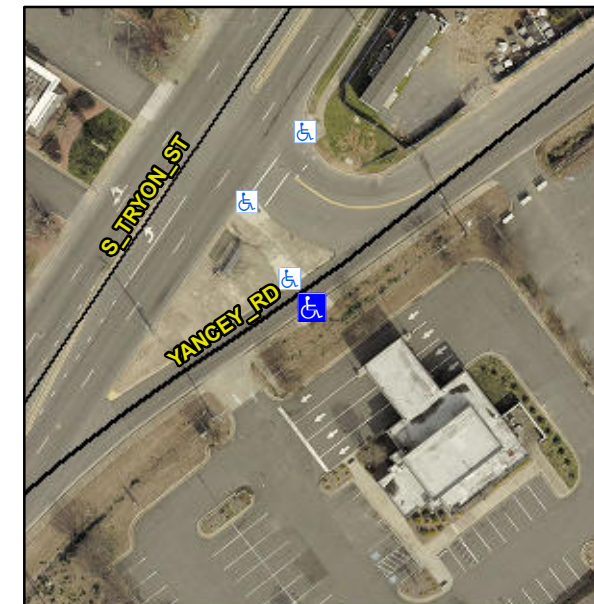
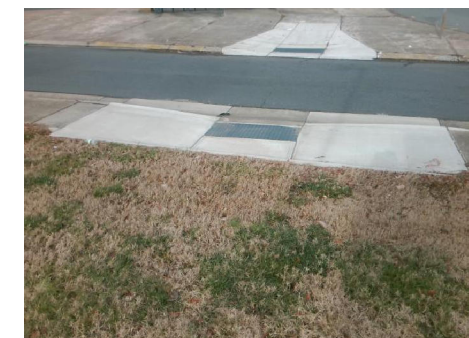
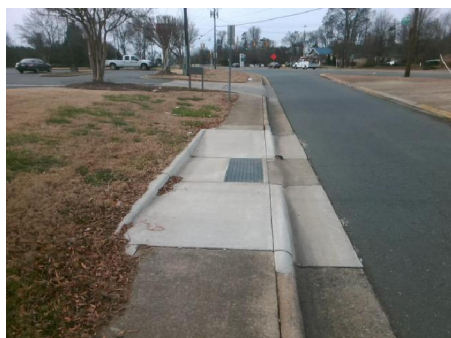
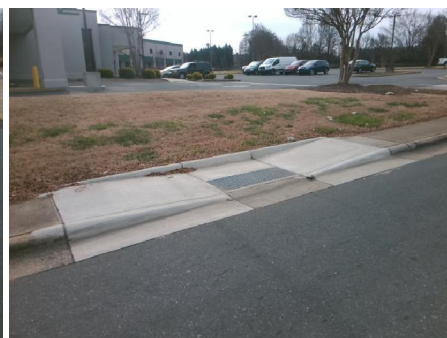
**LT RP < 5%**

**R304.3.2**

Compliance	Description	Data	Compliance	Description	Data
N/A	Ramp Length LT (in)	84.0	N/A	Ramp Length RT (in)	86.0
Yes	Ramp Width LT (in)	58.0	Yes	Ramp Width RT (in)	58.0
Yes	Ramp Slope LT (%)	2.8	No	Ramp Slope RT (%)	11.2
Yes	Ramp XSlope LT (%)	0.5	Yes	Ramp XSlope RT (%)	0.6
N/A	Landing Length (in)	N/A	N/A	DWS Provided?	N/A
N/A	Landing Width (in)	N/A	N/A	DWS Contrast?	N/A
N/A	Landing Slope (%)	N/A	N/A	DWS Length (in)	N/A
N/A	Landing X Slope (%)	N/A	N/A	DWS Full Width?	N/A
N/A	Landing Curb? (Y/N)	N/A	N/A	DWS Offset (in)	N/A
N/A	Shared Landing?	N/A			
N/A	Gutter Ponding?	N/A	N/A	Gutter Slope (%)	N/A
N/A	Gutter Lip Ht (in)	N/A	N/A	Gutter X Slope (%)	N/A
N/A	Painted X Walk1?	No	N/A	Painted X Walk2?	N/A
	X Walk 1 Direction	To NW		X Walk 2 Direction	N/A
N/A	X Walk 1 Width (in)	N/A	N/A	X Walk 2 Width (in)	N/A
	X Walk 1 Slope (%)	4.8		X Walk 2 Slope (%)	N/A
	X Walk 1 X Slope (%)	3.8		X Walk 2 X Slope (%)	N/A
N/A	Ramp inside XWalk1?	N/A	N/A	Ramp inside XWalk2?	N/A

Road Slope (%)	N/A	N/A	Clear Space?	N/A
	Road X Slope (%)	N/A	N/A	Clear Space to XWalk (in)	N/A
N/A	Any Obstructions?	N/A	N/A	Storm Grate/Utility Hazard?	N/A
	Obstruction Type			Storm Grate/Utility Type	
		N/A			N/A
			Yes	Surface Condition? (G/P)	Good
			N/A	Curb Slope (%)	8.4

**Remove & Replace Entire Ramp.**
