# Access Compliance Report

## Public Rights-of-Way

### (Curb Ramps)

Intersection ID: 10022822	Main Street: CASTLE_WATCH_AV	Cross Street: N/A	Location: SE
ADA ID: 799F6307E1E3	Ramp Type: PerpDiag	Initial Pass/Fail: Fail	Overall Compliance: No
Severity Score: 48.75			
Codes/Mitigation Info/Possible Solution		Field Measurements/Component Compliance

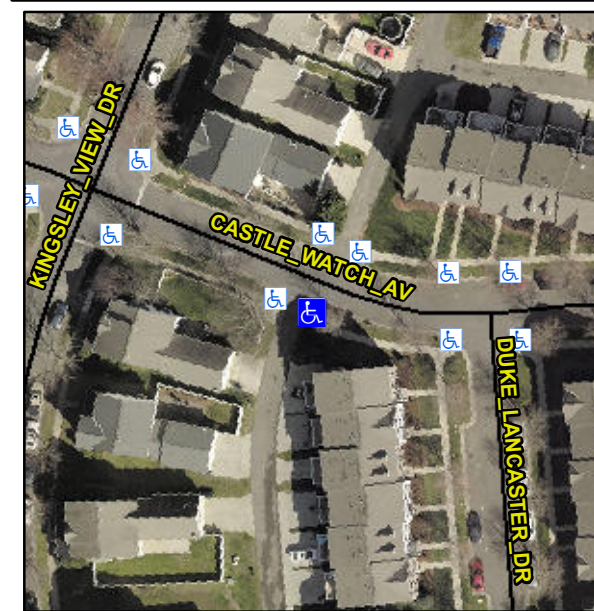
Compliance	Description	Data	Compliance	Description	Data
N/A	Ramp Length (in)	226.0	Yes	Ramp Slope (%)	9.3
No	Ramp Width (in)	25.5	Yes	Ramp XSlope (%)	2.7
N/A	Flare Type LT	N/A	N/A	Flare Type RT	N/A
N/A	Flare Slope LT (%)	N/A	N/A	Flare Slope RT (%)	N/A
N/A	Flare Traversable LT?	N/A	N/A	Flare Traversable RT?	N/A
N/A	Landing Length (in)	N/A	N/A	DWS Provided?	N/A
N/A	Landing Width (in)	N/A	N/A	DWS Contrast?	N/A
N/A	Landing Slope (%)	N/A	N/A	DWS Length (in)	N/A
N/A	Landing X Slope (%)	N/A	N/A	DWS Full Width?	N/A
N/A	Landing Curb? (Y/N)	N/A	N/A	DWS Offset (in)	N/A
N/A	Shared Landing?	N/A			
N/A	Gutter Ponding?	N/A	N/A	Gutter Slope (%)	N/A
N/A	Gutter Lip Ht (in)	N/A	N/A	Gutter X Slope (%)	N/A
N/A	Painted X Walk1?	No	N/A	Painted X Walk2?	No
	X Walk 1 Direction	To NE		X Walk 2 Direction	To NW
N/A	X Walk 1 Width (in)	N/A	N/A	X Walk 2 Width (in)	N/A
	X Walk 1 Slope (%)	2.0		X Walk 2 Slope (%)	3.7
	X Walk 1 X Slope (%)	2.0		X Walk 2 X Slope (%)	3.8

N/A	Ramp inside XWalk1?	N/A	N/A	Ramp inside XWalk2?	N/A
	Road Slope (%)	3.1	N/A	Clear Space?	N/A
	Road X Slope (%)	0.7	N/A	Clear Space to XWalk (in)	N/A
N/A	Any Obstructions?	N/A	N/A	Storm Grate/Utility Hazard?	N/A
	Obstruction Type			Storm Grate/Utility Type	
		N/A			N/A
			Yes	Surface Condition? (G/P)	Good

**Remove & Replace Curb Ramp With Two New Directional Ramps or Equivalent.**

**Not Found, R304.5.1**

Total Cost: \$ 3200.00
