# Access Compliance Report

## Public Rights-of-Way

### (Curb Ramps)

| Intersection ID: 14014 | Main Street: N_SHARON_AMITY_RD | Cross Street: WILORA_LAKE_RD | Location: NE |

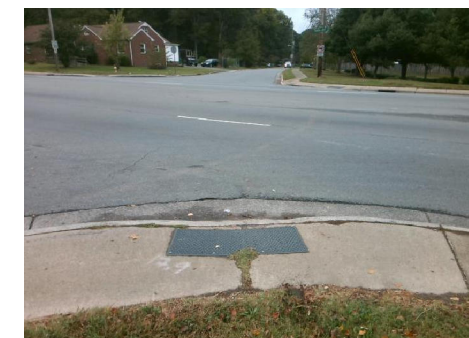
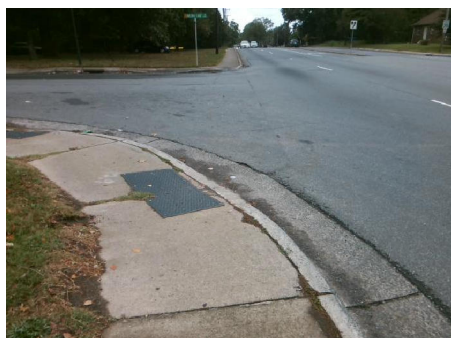
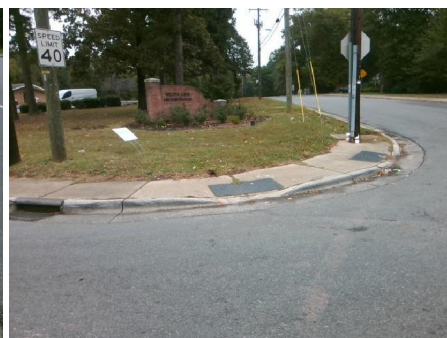
**Not Found, R304.5.1, R304.2.2**

| Compliance | Description | Data | Compliance | Description | Data |
|---|---|---|---|---|---|
| N/A | Ramp Length (in) | 58.5 | No | Ramp Slope (%) | 10.1 |
| No | Ramp Width (in) | 40.0 | Yes | Ramp XSlope (%) | 1.7 |
| N/A | Gutter Ponding? | Yes | N/A | Gutter Slope (%) | N/A |

**Remove & Replace Entire Ramp.**
