# Access Compliance Report

## Public Rights-of-Way

### (Curb Ramps)

Intersection ID: 16451	Main Street: HARTFORD_AV	Cross Street: HOLLIS_RD	Location: NE
ADA ID: 79A5B9AED7FE	Ramp Type: Para	Initial Pass/Fail: Fail	Overall Compliance: No
Severity Score: 13.75			
Codes/Mitigation Info/Possible Solution		Field Measurements/Component Compliance

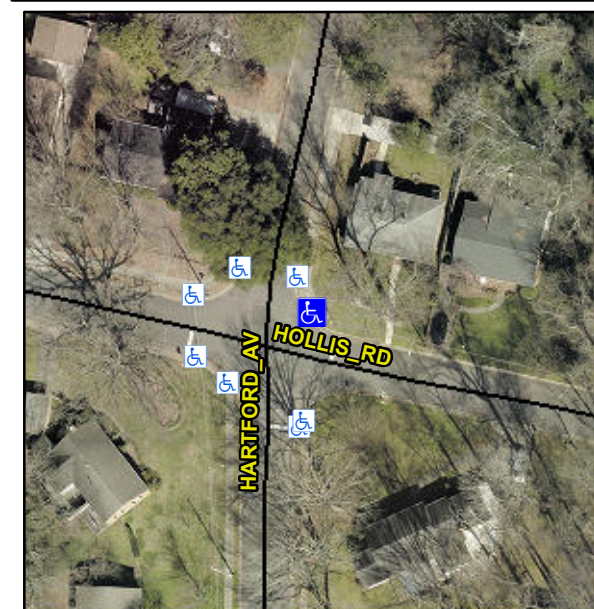
Compliance	Description	Data	Compliance	Description	Data
N/A	Ramp Length LT (in)	52.0	N/A	Ramp Length RT (in)	51.0
Yes	Ramp Width LT (in)	83.0	Yes	Ramp Width RT (in)	80.0
Yes	Ramp Slope LT (%)	5.1	No	Ramp Slope RT (%)	9.6
No	Ramp XSlope LT (%)	2.1	No	Ramp XSlope RT (%)	2.9
N/A	Landing Length (in)	N/A	N/A	DWS Provided?	N/A
N/A	Landing Width (in)	N/A	N/A	DWS Contrast?	N/A
N/A	Landing Slope (%)	N/A	N/A	DWS Length (in)	N/A
N/A	Landing X Slope (%)	N/A	N/A	DWS Full Width?	N/A
N/A	Landing Curb? (Y/N)	N/A	N/A	DWS Offset (in)	N/A
N/A	Shared Landing?	N/A			
N/A	Gutter Ponding?	N/A	N/A	Gutter Slope (%)	N/A
N/A	Gutter Lip Ht (in)	N/A	N/A	Gutter X Slope (%)	N/A
N/A	Painted X Walk1?	No	N/A	Painted X Walk2?	N/A
	X Walk 1 Direction	To S		X Walk 2 Direction	N/A
N/A	X Walk 1 Width (in)	N/A	N/A	X Walk 2 Width (in)	N/A
	X Walk 1 Slope (%)	1.9		X Walk 2 Slope (%)	N/A
	X Walk 1 X Slope (%)	2.0		X Walk 2 X Slope (%)	N/A
N/A	Ramp inside XWalk1?	N/A	N/A	Ramp inside XWalk2?	N/A

Road Slope (%)	N/A	N/A	Clear Space?	N/A
	Road X Slope (%)	N/A	N/A	Clear Space to XWalk (in)	N/A
N/A	Any Obstructions?	N/A	N/A	Storm Grate/Utility Hazard?	N/A
	Obstruction Type			Storm Grate/Utility Type	
		N/A			N/A
			Yes	Surface Condition? (G/P)	Good
			N/A	Curb Slope (%)	3.0

Possible Solutions:

**Remove & Replace Entire Ramp.**

**R304.5.3, R304.3.2**
