Access Compliance Report

Public Rights-of-Way

(Curb Ramps)

Intersection ID: 12998	Main Street: 5TH_ST	Cross Street: MCDOWELL_ST	Location: E
ADA ID: 79A897EF9C4B	Ramp Type: Perp	Initial Pass/Fail: Pass	Overall Compliance: No
Severity Score: 20.25			
Codes/Mitigation Info/Possible Solution		Field Measurements/Component Compliance

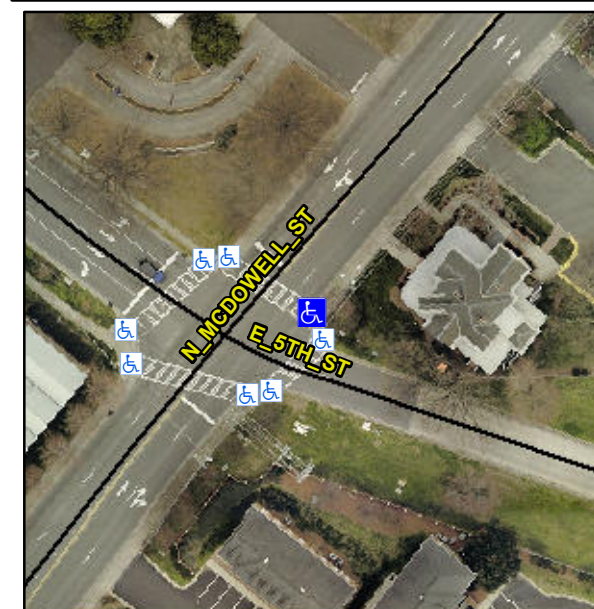
**Not Found, R304.5.3, R304.2.1,
R304.2.2-Perp, R304.3.2-Para,
R304.2.3, R305.2, R304.5.4**

Compliance	Description	Data	Compliance	Description	Data
N/A	Ramp Length (in)	70.0	Yes	Ramp Slope (%)	7.9
Yes	Ramp Width (in)	54.0	No	Ramp XSlope (%)	4.2
N/A	Flare Type LT	Sloped	N/A	Flare Type RT	N/A
N/A	Flare Slope LT (%)	8.9	No	Flare Slope RT (%)	12.6
N/A	Flare Traversable LT?	Yes	N/A	Flare Traversable RT?	Yes
No	Landing Length (in)	N/A	Yes	DWS Provided?	Yes
No	Landing Width (in)	N/A	Yes	DWS Contrast?	Yes
No	Landing Slope (%)	N/A	Yes	DWS Length (in)	24.0
No	Landing X Slope (%)	N/A	Yes	DWS Full Width?	Yes
N/A	Landing Curb? (Y/N)	No	No	DWS Offset (in)	4.5
N/A	Shared Landing?	No			
Yes	Gutter Ponding?	No	No	Gutter Slope (%)	5.3
Yes	Gutter Lip Ht (in)	0.0	Yes	Gutter X Slope (%)	0.9
N/A	Painted X Walk1?	Yes	N/A	Painted X Walk2?	N/A
	X Walk 1 Direction	To NW		X Walk 2 Direction	N/A
N/A	X Walk 1 Width (in)	111.0	N/A	X Walk 2 Width (in)	N/A
	X Walk 1 Slope (%)	1.0		X Walk 2 Slope (%)	N/A
	X Walk 1 X Slope (%)	3.1		X Walk 2 X Slope (%)	N/A

Yes	Ramp inside XWalk1?	Yes	N/A	Ramp inside XWalk2?	N/A
	Road Slope (%)	N/A	N/A	Clear Space?	Yes
	Road X Slope (%)	N/A	N/A	Clear Space to XWalk (in)	N/A
Yes	Any Obstructions?	No	Yes	Storm Grate/Utility Hazard?	No
	Obstruction Type			Storm Grate/Utility Type	
		N/A			N/A
		Yes	Yes	Surface Condition? (G/P)	Good

Possible Solutions:

**Remove & Replace Entire Ramp.
Remove & Replace Gutter.**
