Access Compliance Report

Public Rights-of-Way

(Curb Ramps)

Intersection ID: 16298	Main Street: W_TYVOLA_RD	Cross Street: YORKMONT_RD	Location: SW
ADA ID: 79B2DE95313D	Ramp Type: Perp	Initial Pass/Fail: Fail	Overall Compliance: No
		Severity Score: 67.5

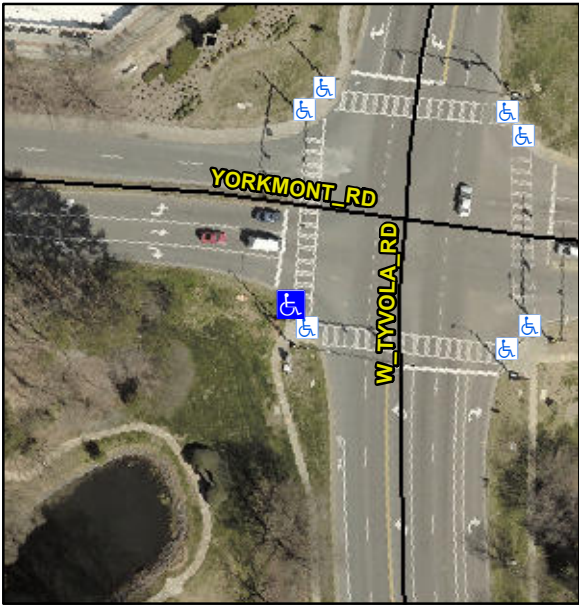
Possible Solutions:		Compliance	Description	Data	Compliance	Description	Data
	Remove & Replace Entire Ramp.		N/A	Ramp Length (in)	73.0	No	Ramp Slope (%)	13.9
			No	Ramp Width (in)	32.0	No	Ramp XSlope (%)	7.5
			N/A	Flare Type LT	N/A	N/A	Flare Type RT	N/A
			N/A	Flare Slope LT (%)	N/A	N/A	Flare Slope RT (%)	N/A
			N/A	Flare Traversable LT?	N/A	N/A	Flare Traversable RT?	N/A
			N/A	Landing Length (in)	N/A	N/A	DWS Provided?	N/A
			N/A	Landing Width (in)	N/A	N/A	DWS Contrast?	N/A
			N/A	Landing Slope (%)	N/A	N/A	DWS Length (in)	N/A
			N/A	Landing X Slope (%)	N/A	N/A	DWS Full Width?	N/A
Surveyor Notes:		N/A	N/A	Landing Curb? (Y/N)	N/A	N/A	DWS Offset (in)	N/A
		N/A	Shared Landing?	N/A				
PROW/ADA:		R304.5.1, R304.2.2, R304.5.3	N/A	Gutter Ponding?	N/A	N/A	Gutter Slope (%)	N/A
			N/A	Gutter Lip Ht (in)	N/A	N/A	Gutter X Slope (%)	N/A

N/A	Painted X Walk1?	Yes	N/A	Painted X Walk2?	N/A
				X Walk 1 Direction	To N		X Walk 2 Direction	N/A
			N/A	X Walk 1 Width (in)	97.0	N/A	X Walk 2 Width (in)	N/A
				X Walk 1 Slope (%)	0.9		X Walk 2 Slope (%)	N/A
				X Walk 1 X Slope (%)	5.8		X Walk 2 X Slope (%)	N/A
			N/A	Ramp inside XWalk1?	Yes	N/A	Ramp inside XWalk2?	N/A
				Road Slope (%)	N/A	N/A	Clear Space?	N/A
				Road X Slope (%)	N/A	N/A	Clear Space to XWalk (in)	N/A
			N/A	Any Obstructions?	N/A	N/A	Storm Grate/Utility Hazard?	N/A
				Obstruction Type			Storm Grate/Utility Type	
					N/A			N/A
						Yes	Surface Condition? (G/P)	Good
		</
