# Access Compliance Report

## Public Rights-of-Way

### (Curb Ramps)

Intersection ID: 4687	Main Street: EVANSHIRE_DR	Cross Street: FELDBANK_DR	Location: SW
ADA ID: 79BA53EA88B4	Ramp Type: BlendTrans2	Initial Pass/Fail: Fail	Overall Compliance: No
Severity Score: 8.75			
Codes/Mitigation Info/Possible Solution		Field Measurements/Component Compliance

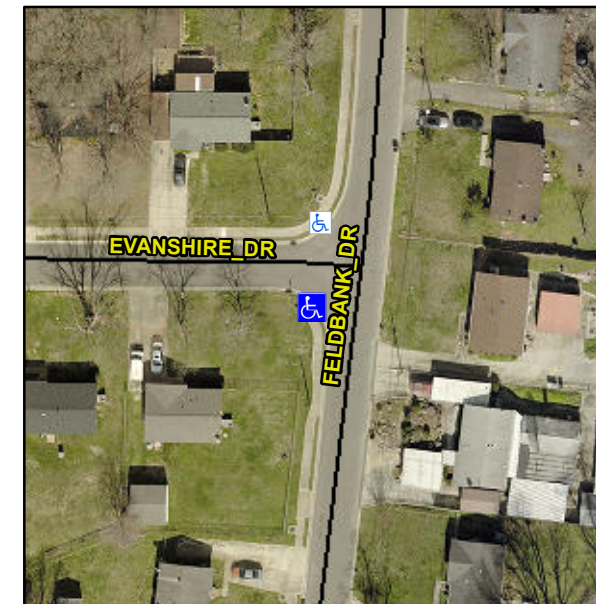
**NO RT SW**

**Not Found, R304.5.1**

Compliance	Description	Data	Compliance	Description	Data
N/A	Ramp Length (in)	83.0	Yes	BlendTrans Slope (%)	4.1
No	Ramp Width (in)	38.0	Yes	BlendTrans XSlope (%)	1.2
N/A	Flare Type LT	N/A	N/A	Flare Type RT	N/A
N/A	Flare Slope LT (%)	N/A	N/A	Flare Slope RT (%)	N/A
N/A	Flare Traversable LT?	N/A	N/A	Flare Traversable RT?	N/A
N/A	Landing Length (in)	N/A	N/A	DWS Provided?	N/A
N/A	Landing Width (in)	N/A	N/A	DWS Contrast?	N/A
N/A	Landing Slope (%)	N/A	N/A	DWS Length (in)	N/A
N/A	Landing X Slope (%)	N/A	N/A	DWS Full Width?	N/A
N/A	Landing Curb? (Y/N)	N/A	N/A	DWS Offset (in)	N/A
N/A	Shared Landing?	N/A			
N/A	Gutter Ponding?	N/A	N/A	Gutter Slope (%)	N/A
N/A	Gutter Lip Ht (in)	N/A	N/A	Gutter X Slope (%)	N/A
N/A	Painted X Walk1?	No	N/A	Painted X Walk2?	N/A
	X Walk 1 Direction	To N		X Walk 2 Direction	N/A
	X Walk 1 Width (in)	N/A		X Walk 2 Width (in)	N/A
	X Walk 1 Slope (%)	3.2		X Walk 2 Slope (%)	N/A
	X Walk 1 X Slope (%)	1.5		X Walk 2 X Slope (%)	N/A

N/A	Ramp inside XWalk1?	N/A	N/A	Ramp inside XWalk2?	N/A
	Road Slope (%)	1.5		Clear Space?	N/A
	Road X Slope (%)	3.2	N/A	Clear Space to XWalk (in)	N/A
N/A	Any Obstructions?	N/A	N/A	Storm Grate/Utility Hazard?	N/A
	Obstruction Type			Storm Grate/Utility Type	
		N/A			N/A
			Yes	Surface Condition? (G/P)	Good
			No	Curb Slope (%)	18.3

**Remove & Replace Curb Ramp With Two New Directional Ramps or Equivalent.**
