# Access Compliance Report

## Public Rights-of-Way

Intersection ID: 12215	Main Street: MIDLAND_AV	Cross Street: DAVIS_AV	Location: NW
ADA ID: 79BA7EE20C98	Ramp Type: BlendTrans1	Initial Pass/Fail: Fail	Overall Compliance: No
		Severity Score: 8.75

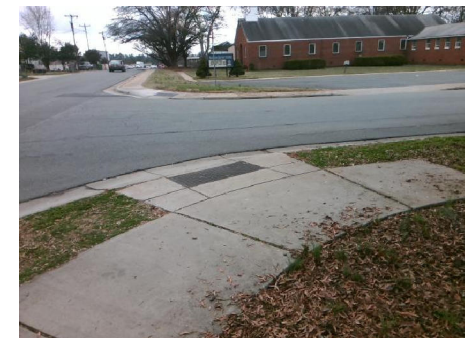
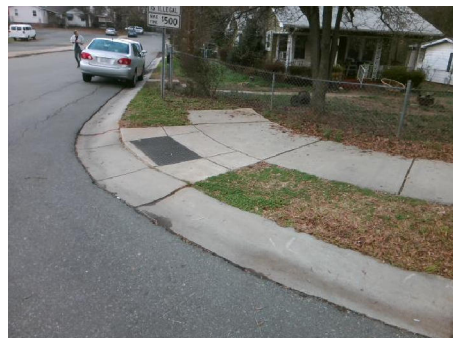
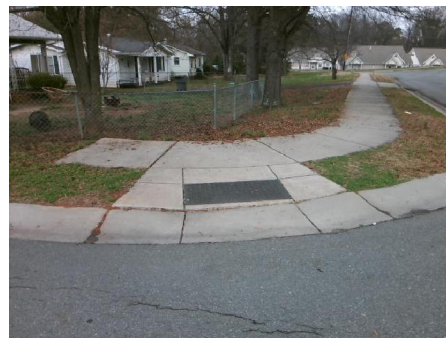
Compliance	Description	Data	Compliance	Description	Data
N/A	Ramp Length (in)	50.5	Yes	BlendTrans Slope (%)	4.7
No	Ramp Width (in)	47.5	Yes	BlendTrans XSlope (%)	0.6
N/A	Flare Type LT	N/A	N/A	Flare Type RT	N/A
N/A	Flare Slope LT (%)	N/A	N/A	Flare Slope RT (%)	N/A
N/A	Flare Traversable LT?	N/A	N/A	Flare Traversable RT?	N/A
N/A	Landing Length (in)	N/A	N/A	DWS Provided?	N/A
N/A	Landing Width (in)	N/A	N/A	DWS Contrast?	N/A
N/A	Landing Slope (%)	N/A	N/A	DWS Length (in)	N/A
N/A	Landing X Slope (%)	N/A	N/A	DWS Full Width?	N/A
N/A	Landing Curb? (Y/N)	N/A	N/A	DWS Offset (in)	N/A
N/A	Shared Landing?	N/A			
N/A	Gutter Ponding?	N/A	N/A	Gutter Slope (%)	N/A
N/A	Gutter Lip Ht (in)	N/A	N/A	Gutter X Slope (%)	N/A
N/A	Painted X Walk1?	No	N/A	Painted X Walk2?	N/A
	X Walk 1 Direction	To S		X Walk 2 Direction	N/A
	X Walk 1 Width (in)	N/A		X Walk 2 Width (in)	N/A
	X Walk 1 Slope (%)	5.0		X Walk 2 Slope (%)	N/A
	X Walk 1 X Slope (%)	2.2		X Walk 2 X Slope (%)	N/A

N/A	Ramp inside XWalk1?	N/A	N/A	Ramp inside XWalk2?	N/A
	Road Slope (%)	2.2		Clear Space?	N/A
	Road X Slope (%)	5.0	N/A	Clear Space to XWalk (in)	N/A
N/A	Any Obstructions?	N/A	N/A	Storm Grate/Utility Hazard?	N/A
	Obstruction Type			Storm Grate/Utility Type	
		N/A			N/A
			Yes	Surface Condition? (G/P)	Good
			No	Curb Slope (%)	10.1

**Remove & Replace Curb Ramp With Two New Directional Ramps or Equivalent.**

**Not Found, R304.5.1**
