Access Compliance Report

Public Rights-of-Way

(Curb Ramps)

Intersection ID: 16126	Main Street: E_W_T_HARRIS_BV	Cross Street: IDLEWILD_RD	Location: SE
ADA ID: 79C3A3D929DB	Ramp Type: Perp	Initial Pass/Fail: Fail	Overall Compliance: No
		Severity Score: 25

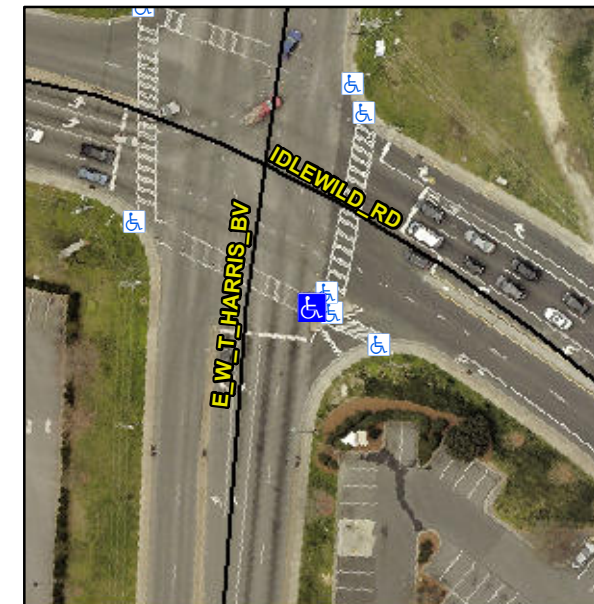
Compliance	Description	Data	Compliance	Description	Data
N/A	Ramp Length (in)	53.0	No	Ramp Slope (%)	16.1
Yes	Ramp Width (in)	48.0	Yes	Ramp XSlope (%)	0.7
N/A	Flare Type LT	N/A	N/A	Flare Type RT	N/A
N/A	Flare Slope LT (%)	N/A	N/A	Flare Slope RT (%)	N/A
N/A	Flare Traversable LT?	N/A	N/A	Flare Traversable RT?	N/A
N/A	Landing Length (in)	N/A	N/A	DWS Provided?	N/A
N/A	Landing Width (in)	N/A	N/A	DWS Contrast?	N/A
N/A	Landing Slope (%)	N/A	N/A	DWS Length (in)	N/A
N/A	Landing X Slope (%)	N/A	N/A	DWS Full Width?	N/A
N/A	Landing Curb? (Y/N)	N/A	N/A	DWS Offset (in)	N/A
N/A	Shared Landing?	N/A			
N/A	Gutter Ponding?	N/A	N/A	Gutter Slope (%)	N/A
N/A	Gutter Lip Ht (in)	N/A	N/A	Gutter X Slope (%)	N/A
N/A	Painted X Walk1?	Yes	N/A	Painted X Walk2?	N/A
	X Walk 1 Direction	To NW		X Walk 2 Direction	N/A
N/A	X Walk 1 Width (in)	107.0	N/A	X Walk 2 Width (in)	N/A
	X Walk 1 Slope (%)	0.9		X Walk 2 Slope (%)	N/A
	X Walk 1 X Slope (%)	1.4		X Walk 2 X Slope (%)	N/A

N/A	Ramp inside XWalk1?	Yes	N/A	Ramp inside XWalk2?	N/A
	Road Slope (%)	N/A	N/A	Clear Space?	N/A
	Road X Slope (%)	N/A	N/A	Clear Space to XWalk (in)	N/A
N/A	Any Obstructions?	N/A	N/A	Storm Grate/Utility Hazard?	N/A
	Obstruction Type			Storm Grate/Utility Type	
		N/A			N/A
			Yes	Surface Condition? (G/P)	Good

Remove & Replace Entire Ramp.
