# Access Compliance Report

## Public Rights-of-Way

### (Curb Ramps)

Intersection ID: 42718	Main Street: PICKEREL_LN	Cross Street: PLANTAIN_CT	Location:	N
ADA ID: 79C49BB1B7AA	Ramp Type: PerpDiag	Initial Pass/Fail: Fail	Overall Compliance: No	Severity Score: 8.75
Codes/Mitigation Info/Possible Solution		Field Measurements/Component Compliance

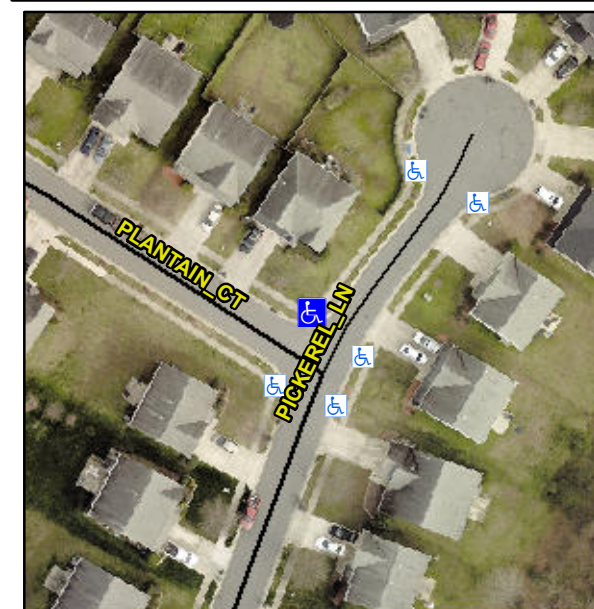
Compliance	Description	Data	Compliance	Description	Data
N/A	Ramp Length (in)	48.0	Yes	Ramp Slope (%)	7.1
No	Ramp Width (in)	39.5	Yes	Ramp XSlope (%)	1.0
N/A	Flare Type LT	N/A	N/A	Flare Type RT	N/A
N/A	Flare Slope LT (%)	N/A	N/A	Flare Slope RT (%)	N/A
N/A	Flare Traversable LT?	N/A	N/A	Flare Traversable RT?	N/A
N/A	Landing Length (in)	N/A	N/A	DWS Provided?	N/A
N/A	Landing Width (in)	N/A	N/A	DWS Contrast?	N/A
N/A	Landing Slope (%)	N/A	N/A	DWS Length (in)	N/A
N/A	Landing X Slope (%)	N/A	N/A	DWS Full Width?	N/A
N/A	Landing Curb? (Y/N)	N/A	N/A	DWS Offset (in)	N/A
N/A	Shared Landing?	N/A			
N/A	Gutter Ponding?	N/A	N/A	Gutter Slope (%)	N/A
N/A	Gutter Lip Ht (in)	N/A	N/A	Gutter X Slope (%)	N/A
N/A	Painted X Walk1?	No	N/A	Painted X Walk2?	No
	X Walk 1 Direction	To SW		X Walk 2 Direction	To SE
N/A	X Walk 1 Width (in)	N/A	N/A	X Walk 2 Width (in)	N/A
	X Walk 1 Slope (%)	2.7		X Walk 2 Slope (%)	0.8
	X Walk 1 X Slope (%)	0.8		X Walk 2 X Slope (%)	2.9

N/A	Ramp inside XWalk1?	N/A	N/A	Ramp inside XWalk2?	N/A
	Road Slope (%)	3.1	N/A	Clear Space?	N/A
	Road X Slope (%)	2.4	N/A	Clear Space to XWalk (in)	N/A
N/A	Any Obstructions?	N/A	N/A	Storm Grate/Utility Hazard?	N/A
	Obstruction Type			Storm Grate/Utility Type	
		N/A			N/A
			Yes	Surface Condition? (G/P)	Good

Possible Solutions:

**Remove & Replace Curb Ramp With Two New Directional Ramps or Equivalent.**

**Not Found, R304.5.1**
