Access Compliance Report

Public Rights-of-Way

(Curb Ramps)

Intersection ID: 14195	Main Street: CLEVELAND_AV	Cross Street: EAST_BV	Location: NE
ADA ID: 79E1A57D6957	Ramp Type: Perp	Initial Pass/Fail: Fail	Overall Compliance: No
Severity Score: 1.25			
Codes/Mitigation Info/Possible Solution		Field Measurements/Component Compliance

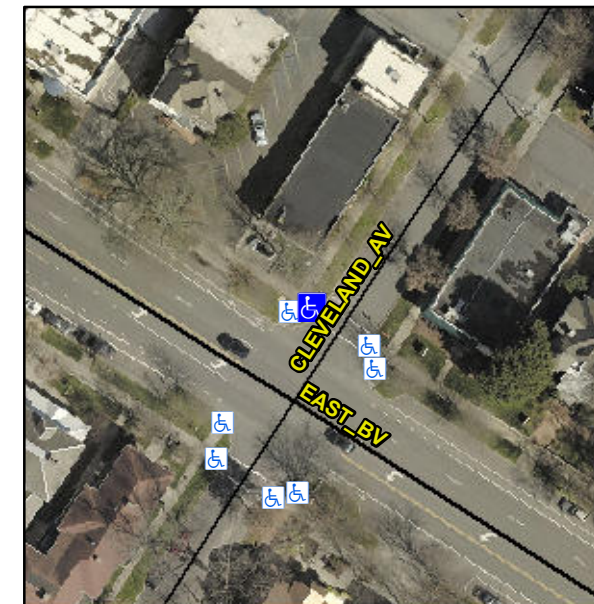
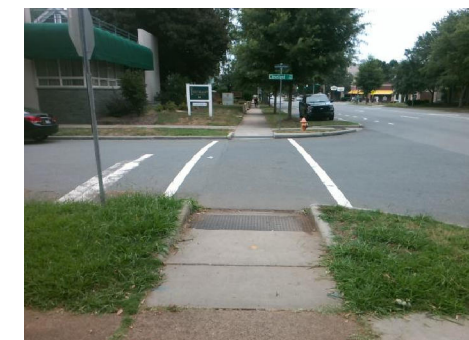
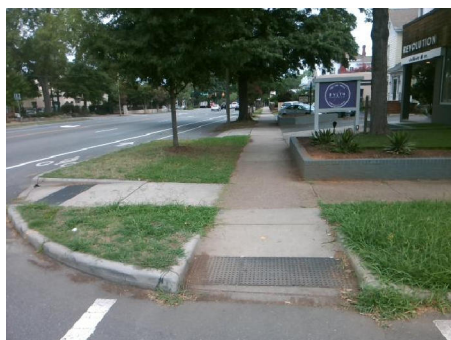
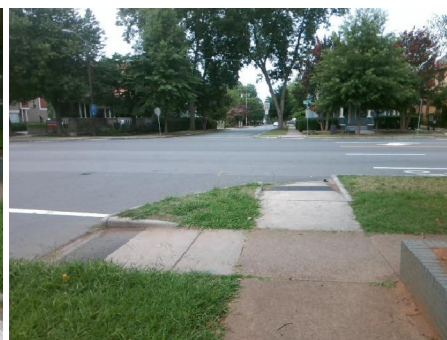
Not Found, R304.5.3

Compliance	Description	Data	Compliance	Description	Data
N/A	Ramp Length (in)	71.0	Yes	Ramp Slope (%)	5.9
Yes	Ramp Width (in)	71.0	No	Ramp XSlope (%)	2.6
N/A	Flare Type LT	N/A	N/A	Flare Type RT	N/A
N/A	Flare Slope LT (%)	N/A	N/A	Flare Slope RT (%)	N/A
N/A	Flare Traversable LT?	N/A	N/A	Flare Traversable RT?	N/A
N/A	Landing Length (in)	N/A	N/A	DWS Provided?	N/A
N/A	Landing Width (in)	N/A	N/A	DWS Contrast?	N/A
N/A	Landing Slope (%)	N/A	N/A	DWS Length (in)	N/A
N/A	Landing X Slope (%)	N/A	N/A	DWS Full Width?	N/A
N/A	Landing Curb? (Y/N)	N/A	N/A	DWS Offset (in)	N/A
N/A	Shared Landing?	N/A			
N/A	Gutter Ponding?	N/A	N/A	Gutter Slope (%)	N/A
N/A	Gutter Lip Ht (in)	N/A	N/A	Gutter X Slope (%)	N/A
N/A	Painted X Walk1?	Yes	N/A	Painted X Walk2?	N/A
	X Walk 1 Direction	To SE		X Walk 2 Direction	N/A
N/A	X Walk 1 Width (in)	110.0	N/A	X Walk 2 Width (in)	N/A
	X Walk 1 Slope (%)	3.1		X Walk 2 Slope (%)	N/A
	X Walk 1 X Slope (%)	0.6		X Walk 2 X Slope (%)	N/A

N/A	Ramp inside XWalk1?	Yes	N/A	Ramp inside XWalk2?	N/A
	Road Slope (%)	N/A	N/A	Clear Space?	N/A
	Road X Slope (%)	N/A	N/A	Clear Space to XWalk (in)	N/A
N/A	Any Obstructions?	N/A	N/A	Storm Grate/Utility Hazard?	N/A
	Obstruction Type			Storm Grate/Utility Type	
		N/A			N/A
		Yes		Surface Condition? (G/P)	Good

Possible Solutions:

Remove & Replace Entire Ramp.

Total Cost: \$ 1850.00
