Access Compliance Report

Public Rights-of-Way

(Curb Ramps)

Intersection ID: 13780	Main Street: ELIZABETH_AV	Cross Street: N_TORRENCE_ST	Location: S
ADA ID: 79E3BC2D3AC6	Ramp Type: Perp	Initial Pass/Fail: Fail	Overall Compliance: No
		Severity Score: 8.75

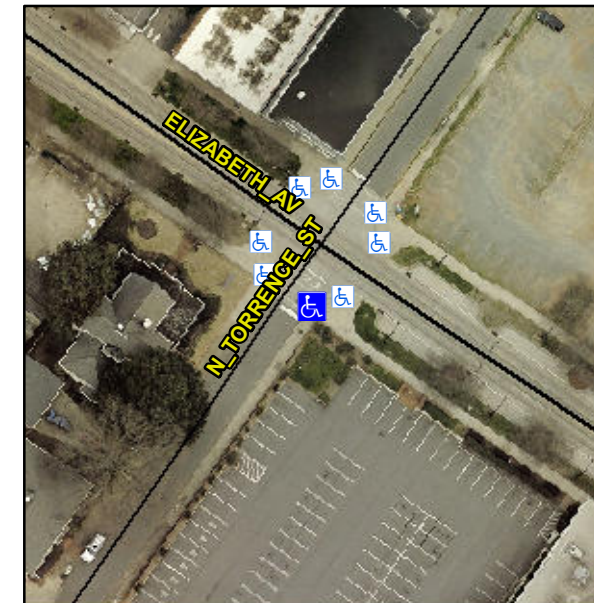
Not Found, R304.5.1

Compliance	Description	Data	Compliance	Description	Data
N/A	Ramp Length (in)	76.0	Yes	Ramp Slope (%)	8.1
No	Ramp Width (in)	47.5	Yes	Ramp XSlope (%)	1.7
N/A	Flare Type LT	N/A	N/A	Flare Type RT	N/A
N/A	Flare Slope LT (%)	N/A	N/A	Flare Slope RT (%)	N/A
N/A	Flare Traversable LT?	N/A	N/A	Flare Traversable RT?	N/A
N/A	Landing Length (in)	N/A	N/A	DWS Provided?	N/A
N/A	Landing Width (in)	N/A	N/A	DWS Contrast?	N/A
N/A	Landing Slope (%)	N/A	N/A	DWS Length (in)	N/A
N/A	Landing X Slope (%)	N/A	N/A	DWS Full Width?	N/A
N/A	Landing Curb? (Y/N)	N/A	N/A	DWS Offset (in)	N/A
N/A	Shared Landing?	N/A			
N/A	Gutter Ponding?	N/A	N/A	Gutter Slope (%)	N/A
N/A	Gutter Lip Ht (in)	N/A	N/A	Gutter X Slope (%)	N/A
N/A	Painted X Walk1?	Yes	N/A	Painted X Walk2?	N/A
	X Walk 1 Direction	To NW		X Walk 2 Direction	N/A
N/A	X Walk 1 Width (in)	116.0	N/A	X Walk 2 Width (in)	N/A
	X Walk 1 Slope (%)	3.1		X Walk 2 Slope (%)	N/A
	X Walk 1 X Slope (%)	0.2		X Walk 2 X Slope (%)	N/A

N/A	Ramp inside XWalk1?	Yes	N/A	Ramp inside XWalk2?	N/A
	Road Slope (%)	N/A	N/A	Clear Space?	N/A
	Road X Slope (%)	N/A	N/A	Clear Space to XWalk (in)	N/A
N/A	Any Obstructions?	N/A	N/A	Storm Grate/Utility Hazard?	N/A
	Obstruction Type			Storm Grate/Utility Type	
		N/A			N/A
			Yes	Surface Condition? (G/P)	Good

Remove & Replace Entire Ramp.
