Access Compliance Report

Public Rights-of-Way

(Curb Ramps)

Intersection ID: 7225	Main Street: STATESVILLE_RD	Cross Street: STARITA_RD	Location: SW
ADA ID: 79F05F65A339	Ramp Type: Para	Initial Pass/Fail: Fail	Overall Compliance: No
Severity Score: 13.75			
Codes/Mitigation Info/Possible Solution		Field Measurements/Component Compliance

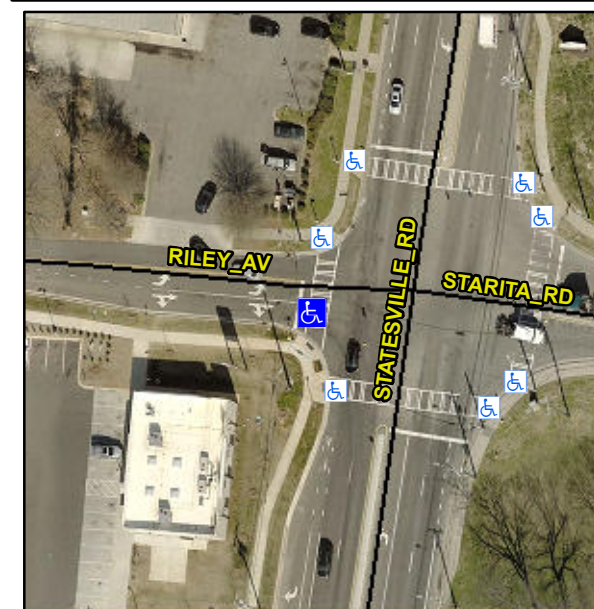
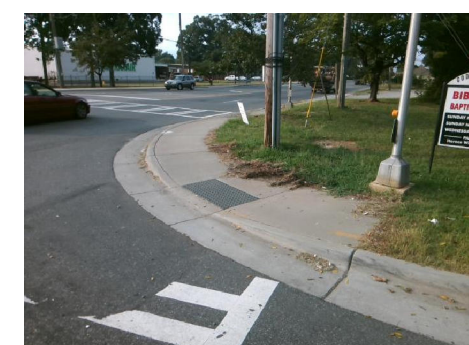
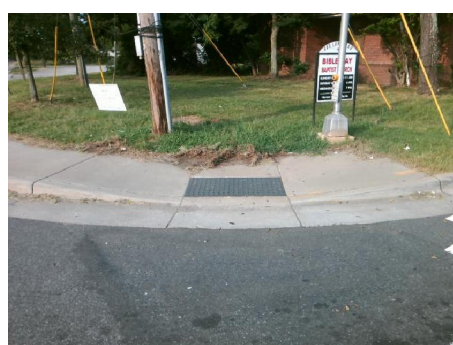
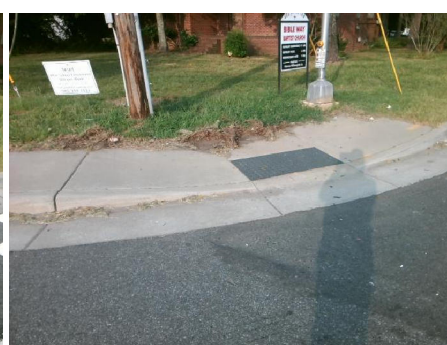
Compliance	Description	Data	Compliance	Description	Data
N/A	Ramp Length LT (in)	58.0	N/A	Ramp Length RT (in)	57.0
Yes	Ramp Width LT (in)	60.0	Yes	Ramp Width RT (in)	59.5
Yes	Ramp Slope LT (%)	6.2	No	Ramp Slope RT (%)	9.3
No	Ramp XSlope LT (%)	3.5	No	Ramp XSlope RT (%)	4.3
N/A	Landing Length (in)	N/A	N/A	DWS Provided?	N/A
N/A	Landing Width (in)	N/A	N/A	DWS Contrast?	N/A
N/A	Landing Slope (%)	N/A	N/A	DWS Length (in)	N/A
N/A	Landing X Slope (%)	N/A	N/A	DWS Full Width?	N/A
N/A	Landing Curb? (Y/N)	N/A	N/A	DWS Offset (in)	N/A
N/A	Shared Landing?	N/A			
N/A	Gutter Ponding?	N/A	N/A	Gutter Slope (%)	N/A
N/A	Gutter Lip Ht (in)	N/A	N/A	Gutter X Slope (%)	N/A
N/A	Painted X Walk1?	Yes	N/A	Painted X Walk2?	N/A
	X Walk 1 Direction	To N		X Walk 2 Direction	N/A
N/A	X Walk 1 Width (in)	111.0	N/A	X Walk 2 Width (in)	N/A
	X Walk 1 Slope (%)	4.1		X Walk 2 Slope (%)	N/A
	X Walk 1 X Slope (%)	0.6		X Walk 2 X Slope (%)	N/A
N/A	Ramp inside XWalk1?	Yes	N/A	Ramp inside XWalk2?	N/A

Road Slope (%)	N/A	N/A	Clear Space?	N/A
	Road X Slope (%)	N/A	N/A	Clear Space to XWalk (in)	N/A
N/A	Any Obstructions?	N/A	N/A	Storm Grate/Utility Hazard?	N/A
	Obstruction Type			Storm Grate/Utility Type	
		N/A			N/A
			Yes	Surface Condition? (G/P)	Good
			N/A	Curb Slope (%)	16.6

Possible Solutions:

Remove & Replace Entire Ramp.
