# Access Compliance Report

## Public Rights-of-Way

### (Curb Ramps)

Intersection ID: 11846	Main Street: BOYER_ST	Cross Street: OLD_DOWD_RD	Location:	E
ADA ID: 79F7EE1869A7	Ramp Type: BlendTrans1	Initial Pass/Fail: Fail	Overall Compliance: No	Severity Score: 10

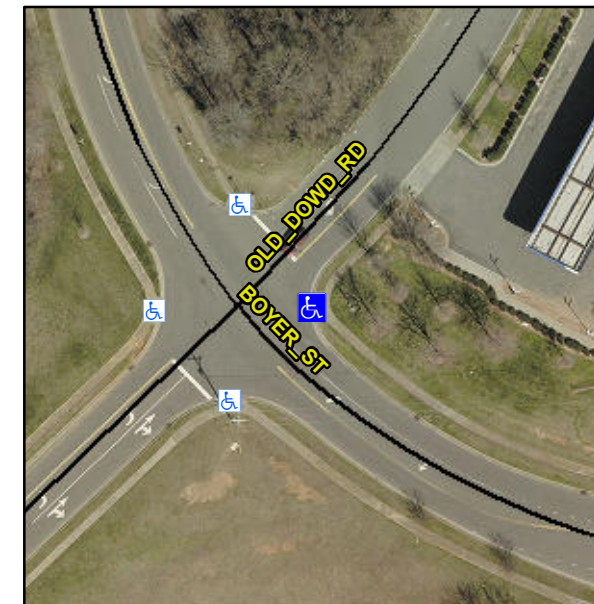
**Not Found, R304.5.1, R304.5.3**

Compliance	Description	Data	Compliance	Description	Data
N/A	Ramp Length (in)	48.0	Yes	BlendTrans Slope (%)	4.7
No	Ramp Width (in)	42.0	No	BlendTrans XSlope (%)	2.1
N/A	Flare Type LT	N/A	N/A	Flare Type RT	N/A
N/A	Flare Slope LT (%)	N/A	N/A	Flare Slope RT (%)	N/A
N/A	Flare Traversable LT?	N/A	N/A	Flare Traversable RT?	N/A
N/A	Landing Length (in)	N/A	N/A	DWS Provided?	N/A
N/A	Landing Width (in)	N/A	N/A	DWS Contrast?	N/A
N/A	Landing Slope (%)	N/A	N/A	DWS Length (in)	N/A
N/A	Landing X Slope (%)	N/A	N/A	DWS Full Width?	N/A
N/A	Landing Curb? (Y/N)	N/A	N/A	DWS Offset (in)	N/A
N/A	Shared Landing?	N/A			
N/A	Gutter Ponding?	N/A	N/A	Gutter Slope (%)	N/A
N/A	Gutter Lip Ht (in)	N/A	N/A	Gutter X Slope (%)	N/A
N/A	Painted X Walk1?	No	N/A	Painted X Walk2?	No
	X Walk 1 Direction	To NW		X Walk 2 Direction	To SW
	X Walk 1 Width (in)	N/A		X Walk 2 Width (in)	N/A
	X Walk 1 Slope (%)	2.6		X Walk 2 Slope (%)	2.3
	X Walk 1 X Slope (%)	1.2		X Walk 2 X Slope (%)	3.3

N/A	Ramp inside XWalk1?	N/A	N/A	Ramp inside XWalk2?	N/A
	Road Slope (%)	4.6		Clear Space?	N/A
	Road X Slope (%)	1.1	N/A	Clear Space to XWalk (in)	N/A
N/A	Any Obstructions?	N/A	N/A	Storm Grate/Utility Hazard?	N/A
	Obstruction Type			Storm Grate/Utility Type	
		N/A			N/A
			Yes	Surface Condition? (G/P)	Good
			No	Curb Slope (%)	13.5

**Remove & Replace Curb Ramp With Two New Directional Ramps or Equivalent.**
