Access Compliance Report

Public Rights-of-Way

(Curb Ramps)

Intersection ID: 2941	Main Street: GOLDENFIELD_DR	Cross Street: SUMMER_CREEK_LN	Location:	E
ADA ID: 79FACEBAB8FF	Ramp Type: Perp	Initial Pass/Fail: Fail	Overall Compliance: No	Severity Score: 22.5
Codes/Mitigation Info/Possible Solution		Field Measurements/Component Compliance

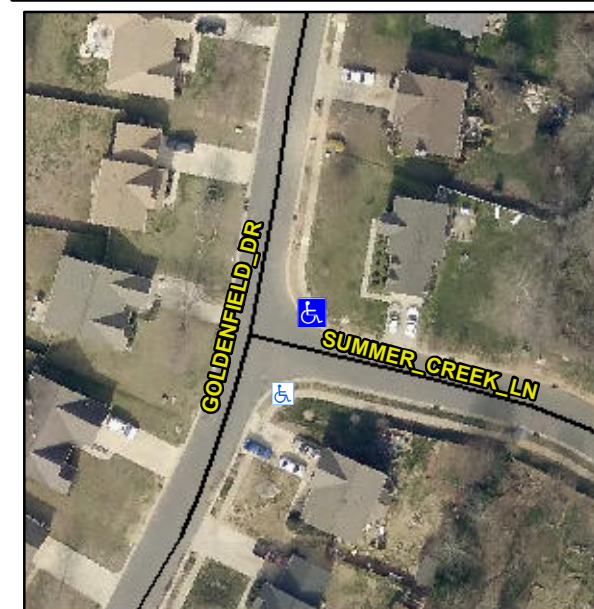
Not Found, R304.5.1, R304.2.2, R304.5.3

Compliance	Description	Data	Compliance	Description	Data
N/A	Ramp Length (in)	45.0	No	Ramp Slope (%)	10.1
No	Ramp Width (in)	43.5	No	Ramp XSlope (%)	3.6
N/A	Flare Type LT	N/A	N/A	Flare Type RT	N/A
N/A	Flare Slope LT (%)	N/A	N/A	Flare Slope RT (%)	N/A
N/A	Flare Traversable LT?	N/A	N/A	Flare Traversable RT?	N/A
N/A	Landing Length (in)	N/A	N/A	DWS Provided?	N/A
N/A	Landing Width (in)	N/A	N/A	DWS Contrast?	N/A
N/A	Landing Slope (%)	N/A	N/A	DWS Length (in)	N/A
N/A	Landing X Slope (%)	N/A	N/A	DWS Full Width?	N/A
N/A	Landing Curb? (Y/N)	N/A	N/A	DWS Offset (in)	N/A
N/A	Shared Landing?	N/A			
N/A	Gutter Ponding?	N/A	N/A	Gutter Slope (%)	N/A
N/A	Gutter Lip Ht (in)	N/A	N/A	Gutter X Slope (%)	N/A
N/A	Painted X Walk1?	No	N/A	Painted X Walk2?	N/A
	X Walk 1 Direction	To SW		X Walk 2 Direction	N/A
N/A	X Walk 1 Width (in)	N/A	N/A	X Walk 2 Width (in)	N/A
	X Walk 1 Slope (%)	0.6		X Walk 2 Slope (%)	N/A
	X Walk 1 X Slope (%)	1.3		X Walk 2 X Slope (%)	N/A

N/A	Ramp inside XWalk1?	N/A	N/A	Ramp inside XWalk2?	N/A
	Road Slope (%)	N/A	N/A	Clear Space?	N/A
	Road X Slope (%)	N/A	N/A	Clear Space to XWalk (in)	N/A
N/A	Any Obstructions?	N/A	N/A	Storm Grate/Utility Hazard?	N/A
	Obstruction Type			Storm Grate/Utility Type	
		N/A			N/A
			Yes	Surface Condition? (G/P)	Good

Possible Solutions:

Remove & Replace Entire Ramp.
