# Access Compliance Report

## Public Rights-of-Way

Intersection ID: 5538	Main Street: GOLDEN_HEIGHTS_CT	Cross Street: NORTHWOODS_FOREST_DR	Location: NE
ADA ID: 79FD46CD3942	Ramp Type: Perp	Initial Pass/Fail: Fail	Overall Compliance: No
Severity Score: 1.25			
Codes/Mitigation Info/Possible Solution		Field Measurements/Component Compliance

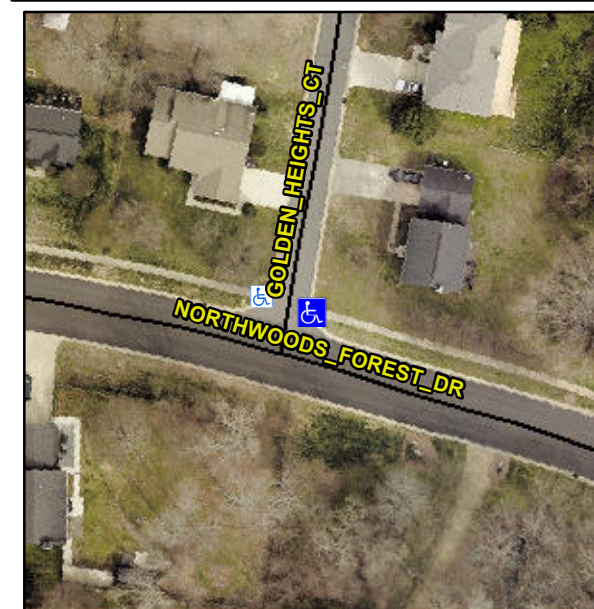
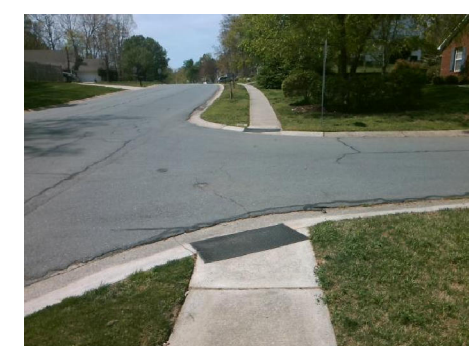
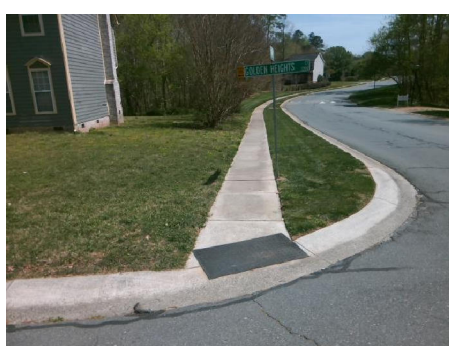
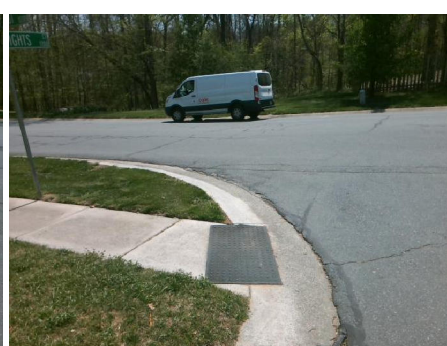
Compliance	Description	Data	Compliance	Description	Data
N/A	Ramp Length (in)	28.0	Yes	Ramp Slope (%)	6.4
Yes	Ramp Width (in)	48.0	No	Ramp XSlope (%)	3.5
N/A	Flare Type LT	N/A	N/A	Flare Type RT	N/A
N/A	Flare Slope LT (%)	N/A	N/A	Flare Slope RT (%)	N/A
N/A	Flare Traversable LT?	N/A	N/A	Flare Traversable RT?	N/A
N/A	Landing Length (in)	N/A	N/A	DWS Provided?	N/A
N/A	Landing Width (in)	N/A	N/A	DWS Contrast?	N/A
N/A	Landing Slope (%)	N/A	N/A	DWS Length (in)	N/A
N/A	Landing X Slope (%)	N/A	N/A	DWS Full Width?	N/A
N/A	Landing Curb? (Y/N)	N/A	N/A	DWS Offset (in)	N/A
N/A	Shared Landing?	N/A			
N/A	Gutter Ponding?	N/A	N/A	Gutter Slope (%)	N/A
N/A	Gutter Lip Ht (in)	N/A	N/A	Gutter X Slope (%)	N/A
N/A	Painted X Walk1?	No	N/A	Painted X Walk2?	N/A
	X Walk 1 Direction	To NW		X Walk 2 Direction	N/A
N/A	X Walk 1 Width (in)	N/A	N/A	X Walk 2 Width (in)	N/A
	X Walk 1 Slope (%)	7.6		X Walk 2 Slope (%)	N/A
	X Walk 1 X Slope (%)	0.1		X Walk 2 X Slope (%)	N/A

N/A	Ramp inside XWalk1?	N/A	N/A	Ramp inside XWalk2?	N/A
	Road Slope (%)	N/A	N/A	Clear Space?	N/A
	Road X Slope (%)	N/A	N/A	Clear Space to XWalk (in)	N/A
N/A	Any Obstructions?	N/A	N/A	Storm Grate/Utility Hazard?	N/A
	Obstruction Type			Storm Grate/Utility Type	
		N/A			N/A
		Yes		Surface Condition? (G/P)	Good

**Remove & Replace Entire Ramp.**

**R304.5.3**

**\$ 1850.00**
