# Access Compliance Report

## Public Rights-of-Way

### (Curb Ramps)

Intersection ID: 18614	Main Street: HUNTER_LN	Cross Street: RANDOLPH_RD	Location: NE
ADA ID: 7A022FC99403	Ramp Type: PerpDiag	Initial Pass/Fail: Fail	Overall Compliance: No
			Severity Score: 13.75

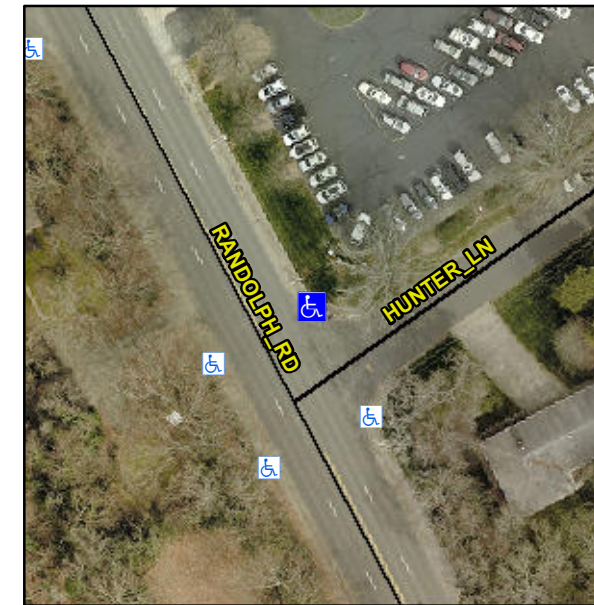
**N/A**

**Not Found, R304.2.2, R304.5.3**

Compliance	Description	Data	Compliance	Description	Data
N/A	Ramp Length (in)	66.5	No	Ramp Slope (%)	8.4
Yes	Ramp Width (in)	48.0	No	Ramp XSlope (%)	2.6
N/A	Flare Type LT	N/A	N/A	Flare Type RT	N/A
N/A	Flare Slope LT (%)	N/A	N/A	Flare Slope RT (%)	N/A
N/A	Flare Traversable LT?	N/A	N/A	Flare Traversable RT?	N/A
N/A	Landing Length (in)	N/A	N/A	DWS Provided?	N/A
N/A	Landing Width (in)	N/A	N/A	DWS Contrast?	N/A
N/A	Landing Slope (%)	N/A	N/A	DWS Length (in)	N/A
N/A	Landing X Slope (%)	N/A	N/A	DWS Full Width?	N/A
N/A	Landing Curb? (Y/N)	N/A	N/A	DWS Offset (in)	N/A
N/A	Shared Landing?	N/A			
N/A	Gutter Ponding?	N/A	N/A	Gutter Slope (%)	N/A
N/A	Gutter Lip Ht (in)	N/A	N/A	Gutter X Slope (%)	N/A
N/A	Painted X Walk1?	No	N/A	Painted X Walk2?	No
	X Walk 1 Direction	To SW		X Walk 2 Direction	To SE
N/A	X Walk 1 Width (in)	N/A	N/A	X Walk 2 Width (in)	N/A
	X Walk 1 Slope (%)	0.5		X Walk 2 Slope (%)	0.5
	X Walk 1 X Slope (%)	0.9		X Walk 2 X Slope (%)	0.8

N/A	Ramp inside XWalk1?	N/A	N/A	Ramp inside XWalk2?	N/A
	Road Slope (%)	1.7	N/A	Clear Space?	N/A
	Road X Slope (%)	3.2	N/A	Clear Space to XWalk (in)	N/A
N/A	Any Obstructions?	N/A	N/A	Storm Grate/Utility Hazard?	N/A
	Obstruction Type			Storm Grate/Utility Type	
		N/A			N/A
			Yes	Surface Condition? (G/P)	Good

**Remove & Replace Curb Ramp With Two New Directional Ramps or Equivalent.**
