Access Compliance Report

Public Rights-of-Way

(Curb Ramps)

Intersection ID: 43493	Main Street: BIRCHFIELD_CT	Cross Street: CHESLEY_DR	Location: NW
ADA ID: 7A0A43C81C4C	Ramp Type: PerpDiag	Initial Pass/Fail: Fail	Overall Compliance: No
Severity Score: 33.75			
Codes/Mitigation Info/Possible Solution		Field Measurements/Component Compliance

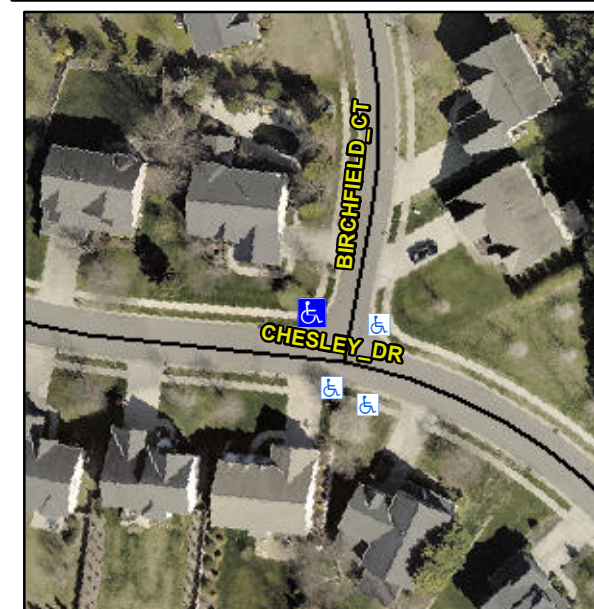
Not Found, R304.5.1, R304.5.3

Compliance	Description	Data	Compliance	Description	Data
N/A	Ramp Length (in)	47.0	Yes	Ramp Slope (%)	6.7
No	Ramp Width (in)	37.0	No	Ramp XSlope (%)	8.7
N/A	Flare Type LT	N/A	N/A	Flare Type RT	N/A
N/A	Flare Slope LT (%)	N/A	N/A	Flare Slope RT (%)	N/A
N/A	Flare Traversable LT?	N/A	N/A	Flare Traversable RT?	N/A
N/A	Landing Length (in)	N/A	N/A	DWS Provided?	N/A
N/A	Landing Width (in)	N/A	N/A	DWS Contrast?	N/A
N/A	Landing Slope (%)	N/A	N/A	DWS Length (in)	N/A
N/A	Landing X Slope (%)	N/A	N/A	DWS Full Width?	N/A
N/A	Landing Curb? (Y/N)	N/A	N/A	DWS Offset (in)	N/A
N/A	Shared Landing?	N/A			
N/A	Gutter Ponding?	N/A	N/A	Gutter Slope (%)	N/A
N/A	Gutter Lip Ht (in)	N/A	N/A	Gutter X Slope (%)	N/A
N/A	Painted X Walk1?	No	N/A	Painted X Walk2?	No
	X Walk 1 Direction	To S		X Walk 2 Direction	To SE
N/A	X Walk 1 Width (in)	N/A	N/A	X Walk 2 Width (in)	N/A
	X Walk 1 Slope (%)	4.3		X Walk 2 Slope (%)	2.6
	X Walk 1 X Slope (%)	4.7		X Walk 2 X Slope (%)	3.6

N/A	Ramp inside XWalk1?	N/A	N/A	Ramp inside XWalk2?	N/A
	Road Slope (%)	6.2	N/A	Clear Space?	N/A
	Road X Slope (%)	0.4	N/A	Clear Space to XWalk (in)	N/A
N/A	Any Obstructions?	N/A	N/A	Storm Grate/Utility Hazard?	N/A
	Obstruction Type			Storm Grate/Utility Type	
		N/A			N/A
		Yes		Surface Condition? (G/P)	Good

Remove & Replace Curb Ramp With Two New Directional Ramps or Equivalent.
