# Access Compliance Report

## Public Rights-of-Way

### (Curb Ramps)

| Intersection ID: 13137 | Main Street: CENTRAL_AV | Cross Street: THOMAS_AV | Location: SE |

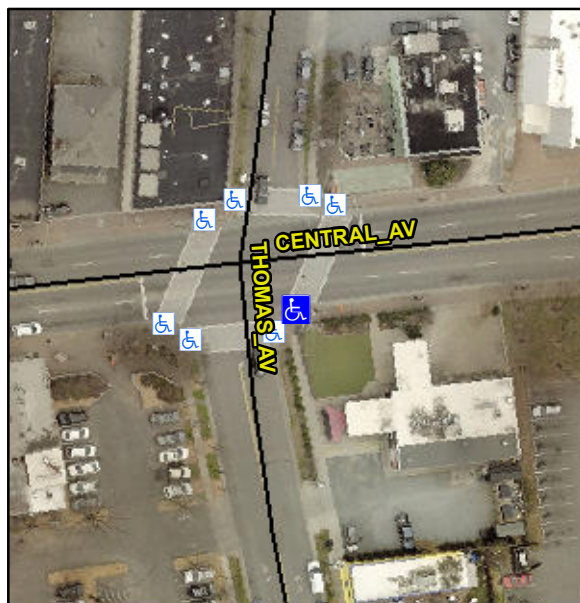
**Not Found, R304.2.2**

| Compliance | Description | Data | Compliance | Description | Data |
|---|---|---|---|---|---|
| N/A | Ramp Length (in) | 66.0 | No | Ramp Slope (%) | 11.1 |

**Remove & Replace Entire Ramp.**

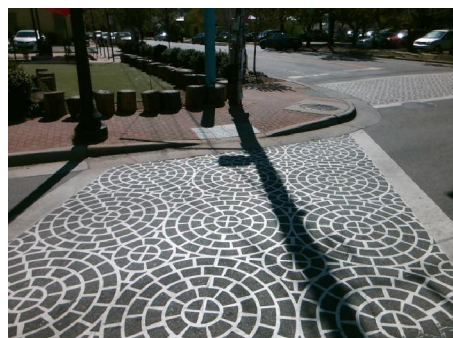
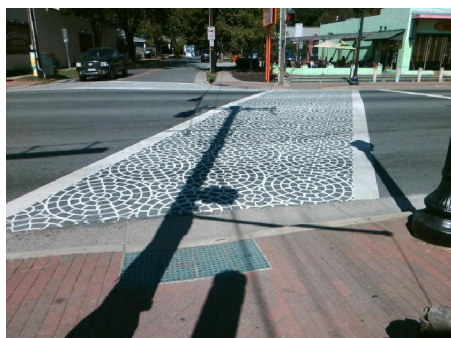
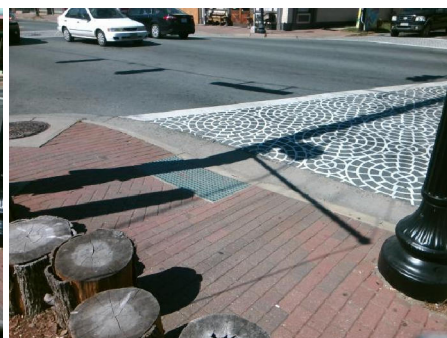
| Compliance | Description | Data | Compliance | Description | Data |
|---|---|---|---|---|---|
| | | | Yes | Surface Condition? (G/P) | Good |
