Access Compliance Report

Public Rights-of-Way

(Curb Ramps)

Intersection ID: 9693	Main Street: MULBERRY_AV	Cross Street: PATTON_AV	Location: SW
ADA ID: 7A1681D7C46A	Ramp Type: Perp	Initial Pass/Fail: Fail	Overall Compliance: No
		Severity Score: 10

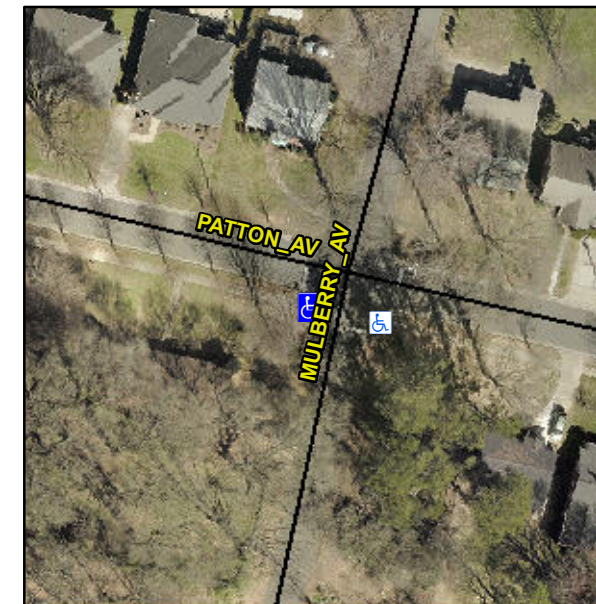
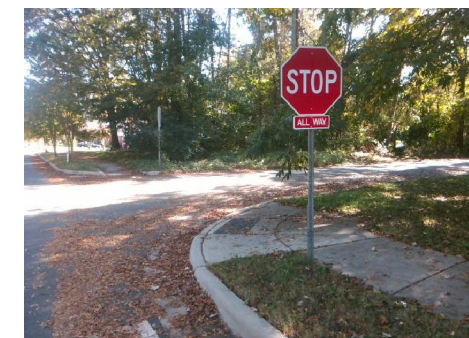
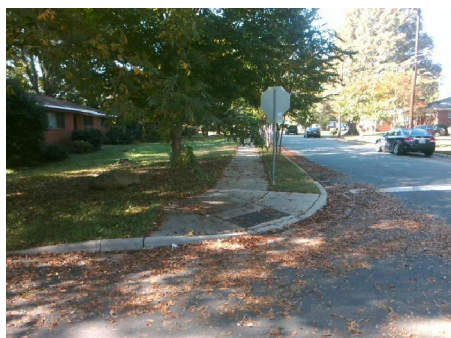
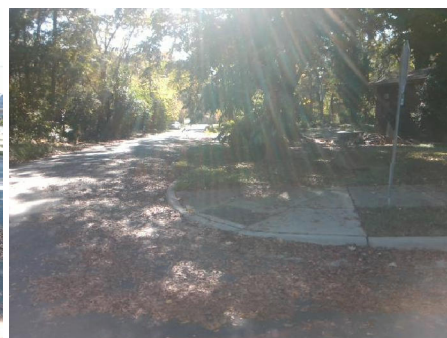
Not Found, R304.5.1, R304.5.3

Compliance	Description	Data	Compliance	Description	Data
N/A	Ramp Length (in)	107.3	Yes	Ramp Slope (%)	6.0
No	Ramp Width (in)	46.5	No	Ramp XSlope (%)	3.3
N/A	Flare Type LT	N/A	N/A	Flare Type RT	N/A
N/A	Flare Slope LT (%)	N/A	N/A	Flare Slope RT (%)	N/A
N/A	Flare Traversable LT?	N/A	N/A	Flare Traversable RT?	N/A
N/A	Landing Length (in)	N/A	N/A	DWS Provided?	N/A
N/A	Landing Width (in)	N/A	N/A	DWS Contrast?	N/A
N/A	Landing Slope (%)	N/A	N/A	DWS Length (in)	N/A
N/A	Landing X Slope (%)	N/A	N/A	DWS Full Width?	N/A
N/A	Landing Curb? (Y/N)	N/A	N/A	DWS Offset (in)	N/A
N/A	Shared Landing?	N/A			
N/A	Gutter Ponding?	N/A	N/A	Gutter Slope (%)	N/A
N/A	Gutter Lip Ht (in)	N/A	N/A	Gutter X Slope (%)	N/A
N/A	Painted X Walk1?	No	N/A	Painted X Walk2?	N/A
	X Walk 1 Direction	To SE		X Walk 2 Direction	N/A
N/A	X Walk 1 Width (in)	N/A	N/A	X Walk 2 Width (in)	N/A
	X Walk 1 Slope (%)	2.1		X Walk 2 Slope (%)	N/A
	X Walk 1 X Slope (%)	3.3		X Walk 2 X Slope (%)	N/A

N/A	Ramp inside XWalk1?	N/A	N/A	Ramp inside XWalk2?	N/A
	Road Slope (%)	N/A	N/A	Clear Space?	N/A
	Road X Slope (%)	N/A	N/A	Clear Space to XWalk (in)	N/A
N/A	Any Obstructions?	N/A	N/A	Storm Grate/Utility Hazard?	N/A
	Obstruction Type			Storm Grate/Utility Type	
		N/A			N/A
			Yes	Surface Condition? (G/P)	Good

Remove & Replace Entire Ramp.
