Access Compliance Report Public Rights-of-Way (Curb Ramps)

Intersection ID: 29820 Main Street: PROVIDENCE RD WEST **Cross Street: WEDGEWOOD COMMONS DR** Location: NE ADA ID: 7A1FF7E74001 Ramp Type: PerpDiag Initial Pass/Fail: Fail **Overall Compliance: No Severity Score:** 8.75

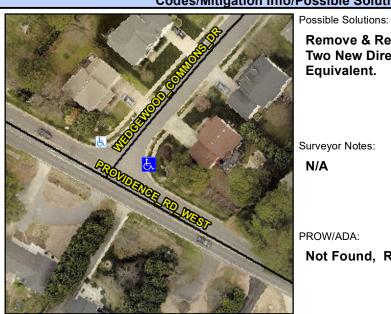
Not Found, R304.5.1

Com	pliance Description	Data	Comp	oliance Description	Data
N/A	Ramp Length (in)	43.0	Yes	Ramp Slope (%)	5.2
No	Ramp Width (in)	47.0	Yes	Ramp XSlope (%)	0.6
N/A	Flare Type LT	N/A	N/A	Flare Type RT	N/A
N/A	Flare Slope LT (%)	N/A	N/A	Flare Slope RT (%)	N/A
N/A	Flare Traversable LT?	N/A	N/A	Flare Traversable RT?	N/A
N/A	Landing Length (in)	N/A	N/A	DWS Provided?	N/A
N/A	Landing Width (in)	N/A	N/A	DWS Contrast?	N/A
N/A	Landing Slope (%)	N/A	N/A	DWS Length (in)	N/A
N/A	Landing X Slope (%)	N/A	N/A	DWS Full Width?	N/A
N/A	Landing Curb? (Y/N)	N/A	N/A	DWS Offset (in)	N/A
N/A	Shared Landing?	N/A			
N/A	Gutter Ponding?	N/A	N/A	Gutter Slope (%)	N/A
N/A	Gutter Lip Ht (in)	N/A	N/A	Gutter X Slope (%)	N/A
N/A	Painted X Walk1?	No	N/A	Painted X Walk2?	No
	X Walk 1 Direction	To NW		X Walk 2 Direction	To SW
N/A	X Walk 1 Width (in)	N/A	N/A	X Walk 2 Width (in)	N/A
	X Walk 1 Slope (%)	3.3		X Walk 2 Slope (%)	1.7
	X Walk 1 X Slope (%)	2.9		X Walk 2 X Slope (%)	3.6

N/A	Ramp inside XWalk1?	N/A	N/A	Ramp inside XWalk2?	N/A
	Road Slope (%)	1.8	N/A	Clear Space?	N/A
	Road X Slope (%)	4.3	N/A	Clear Space to XWalk (in)	N/A
N/A	Any Obstructions?	N/A	N/A	Storm Grate/Utility Hazard?	N/A
	Obstruction Type			Storm Grate/Utility Type	
		N/A			N/A
			Yes	Surface Condition? (G/P)	Good
	100

Remove & Replace Curb Ramp With **Two New Directional Ramps or** Equivalent.
