Access Compliance Report

Public Rights-of-Way

(Curb Ramps)

Intersection ID: 14085	Main Street: CARLTON_AV	Cross Street: MT_VERNON_AV	Location: SE
ADA ID: 7A2319BC2B04	Ramp Type: Perp	Initial Pass/Fail: Fail	Overall Compliance: No
Severity Score: 22.5			
Codes/Mitigation Info/Possible Solution		Field Measurements/Component Compliance

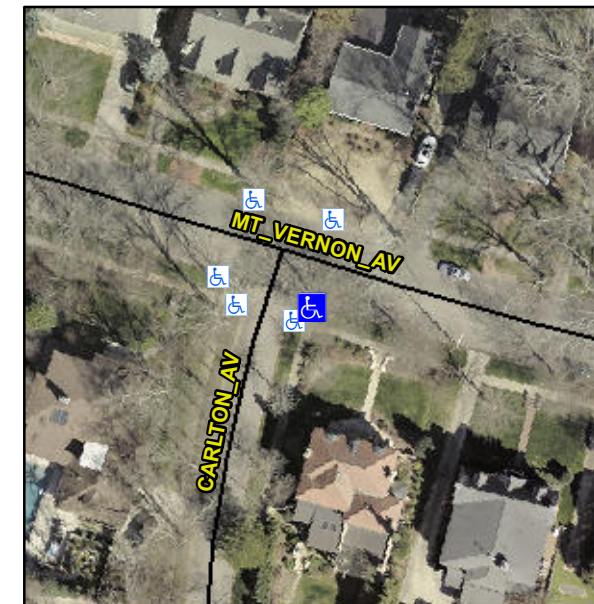
Compliance	Description	Data	Compliance	Description	Data
N/A	Ramp Length (in)	94.0	No	Ramp Slope (%)	8.8
No	Ramp Width (in)	43.0	No	Ramp XSlope (%)	3.5
N/A	Flare Type LT	N/A	N/A	Flare Type RT	N/A
N/A	Flare Slope LT (%)	N/A	N/A	Flare Slope RT (%)	N/A
N/A	Flare Traversable LT?	N/A	N/A	Flare Traversable RT?	N/A
N/A	Landing Length (in)	N/A	N/A	DWS Provided?	N/A
N/A	Landing Width (in)	N/A	N/A	DWS Contrast?	N/A
N/A	Landing Slope (%)	N/A	N/A	DWS Length (in)	N/A
N/A	Landing X Slope (%)	N/A	N/A	DWS Full Width?	N/A
N/A	Landing Curb? (Y/N)	N/A	N/A	DWS Offset (in)	N/A
N/A	Shared Landing?	N/A			
N/A	Gutter Ponding?	N/A	N/A	Gutter Slope (%)	N/A
N/A	Gutter Lip Ht (in)	N/A	N/A	Gutter X Slope (%)	N/A
N/A	Painted X Walk1?	No	N/A	Painted X Walk2?	N/A
	X Walk 1 Direction	To NE		X Walk 2 Direction	N/A
N/A	X Walk 1 Width (in)	N/A	N/A	X Walk 2 Width (in)	N/A
	X Walk 1 Slope (%)	4.5		X Walk 2 Slope (%)	N/A
	X Walk 1 X Slope (%)	0.2		X Walk 2 X Slope (%)	N/A

N/A	Ramp inside XWalk1?	N/A	N/A	Ramp inside XWalk2?	N/A
	Road Slope (%)	N/A	N/A	Clear Space?	N/A
	Road X Slope (%)	N/A	N/A	Clear Space to XWalk (in)	N/A
N/A	Any Obstructions?	N/A	N/A	Storm Grate/Utility Hazard?	N/A
	Obstruction Type			Storm Grate/Utility Type	
		N/A			N/A
			Yes	Surface Condition? (G/P)	Good

Possible Solutions:

Remove & Replace Entire Ramp.

R304.5.1, R304.2.2, R304.5.3
