Access Compliance Report

Public Rights-of-Way

(Curb Ramps)

Intersection ID: 27163	Main Street: HEATHERTON_PL	Cross Street: PROVIDENCE_ARBOURS_DR	Location: SW
ADA ID: 7A2C45188A3C	Ramp Type: Perp	Initial Pass/Fail: Fail	Overall Compliance: No
Codes/Mitigation Info/Possible Solution		Field Measurements/Component Compliance	
Severity Score: 13.75

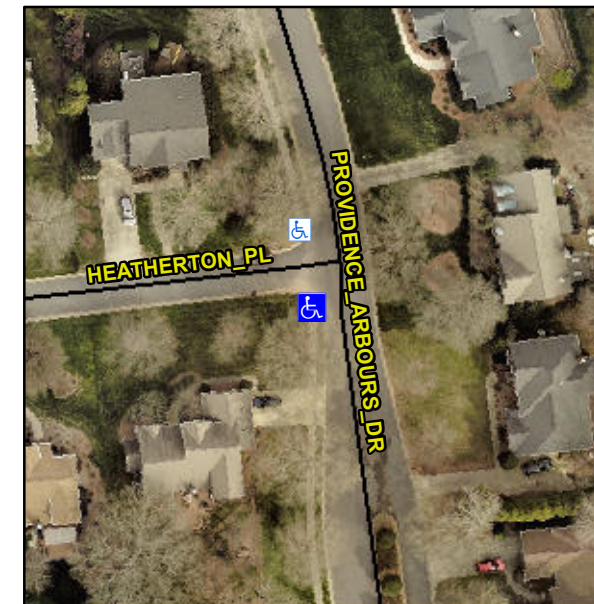
PROW/ADA:

Not Found, R304.2.2, R304.5.3

Compliance	Description	Data	Compliance	Description	Data
N/A	Ramp Length (in)	36.0	No	Ramp Slope (%)	8.6
Yes	Ramp Width (in)	82.0	No	Ramp XSlope (%)	5.0
N/A	Flare Type LT	N/A	N/A	Flare Type RT	N/A
N/A	Flare Slope LT (%)	N/A	N/A	Flare Slope RT (%)	N/A
N/A	Flare Traversable LT?	N/A	N/A	Flare Traversable RT?	N/A
N/A	Landing Length (in)	N/A	N/A	DWS Provided?	N/A
N/A	Landing Width (in)	N/A	N/A	DWS Contrast?	N/A
N/A	Landing Slope (%)	N/A	N/A	DWS Length (in)	N/A
N/A	Landing X Slope (%)	N/A	N/A	DWS Full Width?	N/A
N/A	Landing Curb? (Y/N)	N/A	N/A	DWS Offset (in)	N/A
N/A	Shared Landing?	N/A			
N/A	Gutter Ponding?	N/A	N/A	Gutter Slope (%)	N/A
N/A	Gutter Lip Ht (in)	N/A	N/A	Gutter X Slope (%)	N/A
N/A	Painted X Walk1?	No	N/A	Painted X Walk2?	N/A
	X Walk 1 Direction	To N		X Walk 2 Direction	N/A
N/A	X Walk 1 Width (in)	N/A	N/A	X Walk 2 Width (in)	N/A
	X Walk 1 Slope (%)	3.4		X Walk 2 Slope (%)	N/A
	X Walk 1 X Slope (%)	2.2		X Walk 2 X Slope (%)	N/A

Possible Solutions:

Remove & Replace Entire Ramp.

Total Cost: \$ 1850.00

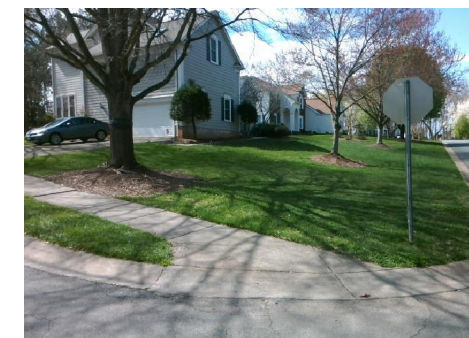
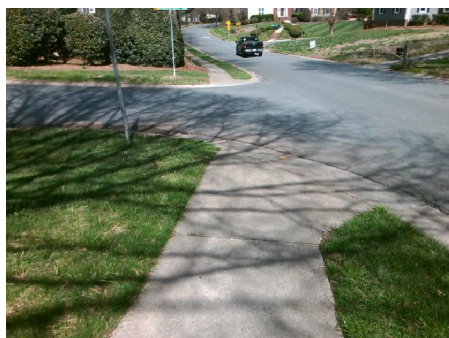
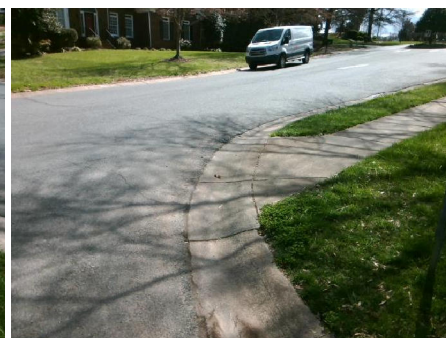
N/A	Ramp inside XWalk1?	N/A	N/A	Ramp inside XWalk2?	N/A
	Road Slope (%)	N/A	N/A	Clear Space?	N/A
	Road X Slope (%)	N/A	N/A	Clear Space to XWalk (in)	N/A
N/A	Any Obstructions?	N/A	N/A	Storm Grate/Utility Hazard?	N/A
	Obstruction Type			Storm Grate/Utility Type	
		N/A			N/A
			Yes	Surface Condition? (G/P)	Good
