Access Compliance Report Public Rights-of-Way (Curb Ramps)

Intersection ID: 8041 Main Street: AUSTIN DR Cross Street: N_TRYON_ST Location: W ADA ID: 7A3B30635C3D Ramp Type: Directional1 Initial Pass/Fail: Pass **Overall Compliance: No Severity Score:** 15

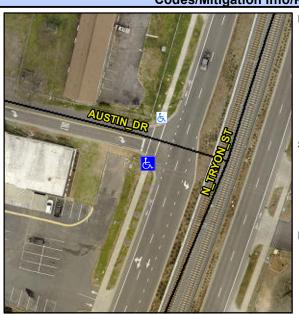
Field Measurements/Component Compliance					
Compliance Description		Data	Comp	liance Description	Data
N/A	Ramp Length (in)	137.0	Yes	Grade Break?	Yes
Yes	Ramp Width (in)	68.0	Yes	Grade Break Slope (%)	3.0
Yes	Ramp Slope (%)	7.6	No	Grade Break XSlope (%)	2.
Yes	Ramp XSlope (%)	0.6			
Yes	Flare Type LT	N/A	Yes	Flare Type RT	N/A
N/A	Flare Slope LT (%)	N/A	N/A	Flare Slope RT (%)	N/A
N/A	Flare Traversable LT?	No	N/A	Flare Traversable RT?	No
Yes	Landing Length (in)	61.0	Yes	DWS Provided?	Yes
Yes	Landing Width (in)	70.0	Yes	DWS Contrast?	Yes
Yes	Landing Slope (%)	0.2	Yes	DWS Length (in)	24.0
Yes	Landing X Slope (%)	1.7	Yes	DWS Full Width?	Yes
N/A	Landing Curb? (Y/N)	N/A	No	DWS Offset LT (in)	5.0
N/A	Shared Landing?	No	Yes	DWS Offset RT (in)	56.0
Yes	Gutter Ponding?	No	Yes	Gutter Slope (%)	2.
No	Gutter Lip Ht (in)	0.8	No	Gutter X Slope (%)	3.3
N/A	Painted X Walk1?	No		Road Slope (%)	0.8
	X Walk 1 Direction	To N		Road X Slope (%)	3.

X Walk 1 Width (in)	N/A		Clear Space?	Yes
	X Walk 1 Slope (%)	0.8	N/A	Clear Space to XWalk (in)	N/A
	X Walk 1 X Slope (%)	3.1	No	Storm Grate/Utility Hazard?	Yes
N/A	Ramp inside XWalk1?	N/A		Storm Grate/Utility Type	
Yes	Any Obstructions?	No		GAS VAL GTF	
	Obstruction Type		Yes	Surface Condition? (G/P)	Good
		N/A	No	Curb Slope (%)	9.3

Possible Solutions: Remove & Replace Entire Ramp. Remove & Replace Gutter. Utility Present. Surveyor Notes: N/A PROW/ADA: Not Found, R304.5.3, R305.2, R302.7.2, R302.3, R402.2
