# Access Compliance Report

## Public Rights-of-Way

### (Curb Ramps)

Intersection ID: 29562	Main Street: MCGLOUGHLIN WAY CT	Cross Street: TIOGA LN	Location:	NW
ADA ID: 7A702FDA05A4	Ramp Type: PerpDiag	Initial Pass/Fail: Fail	Overall Compliance: No	Severity Score: 60
Codes/Mitigation Info/Possible Solution		Field Measurements/Component Compliance

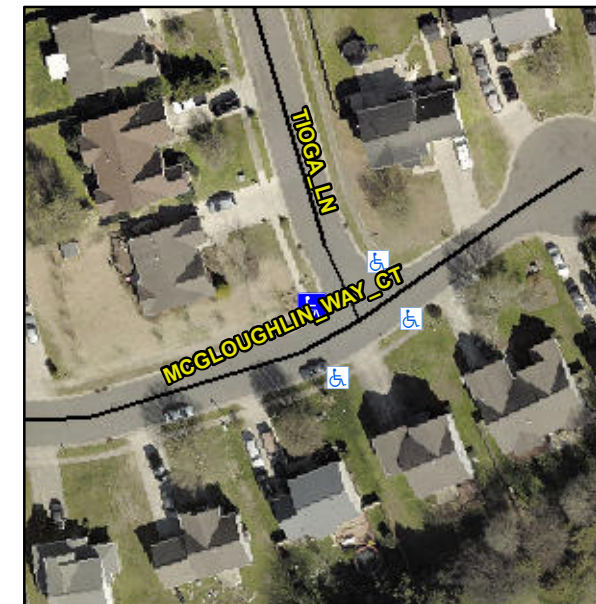
Compliance	Description	Data	Compliance	Description	Data
N/A	Ramp Length (in)	58.0	No	Ramp Slope (%)	9.1
No	Ramp Width (in)	30.0	No	Ramp XSlope (%)	6.3
N/A	Flare Type LT	N/A	N/A	Flare Type RT	N/A
N/A	Flare Slope LT (%)	N/A	N/A	Flare Slope RT (%)	N/A
N/A	Flare Traversable LT?	N/A	N/A	Flare Traversable RT?	N/A
N/A	Landing Length (in)	N/A	N/A	DWS Provided?	N/A
N/A	Landing Width (in)	N/A	N/A	DWS Contrast?	N/A
N/A	Landing Slope (%)	N/A	N/A	DWS Length (in)	N/A
N/A	Landing X Slope (%)	N/A	N/A	DWS Full Width?	N/A
N/A	Landing Curb? (Y/N)	N/A	N/A	DWS Offset (in)	N/A
N/A	Shared Landing?	N/A			
N/A	Gutter Ponding?	N/A	N/A	Gutter Slope (%)	N/A
N/A	Gutter Lip Ht (in)	N/A	N/A	Gutter X Slope (%)	N/A
N/A	Painted X Walk1?	No	N/A	Painted X Walk2?	No
	X Walk 1 Direction	To SE		X Walk 2 Direction	To NE
N/A	X Walk 1 Width (in)	N/A	N/A	X Walk 2 Width (in)	N/A
	X Walk 1 Slope (%)	0.1		X Walk 2 Slope (%)	0.0
	X Walk 1 X Slope (%)	2.3		X Walk 2 X Slope (%)	3.4

N/A	Ramp inside XWalk1?	N/A	N/A	Ramp inside XWalk2?	N/A
	Road Slope (%)	3.8	N/A	Clear Space?	N/A
	Road X Slope (%)	2.1	N/A	Clear Space to XWalk (in)	N/A
N/A	Any Obstructions?	N/A	N/A	Storm Grate/Utility Hazard?	N/A
	Obstruction Type			Storm Grate/Utility Type	
		N/A			N/A
			Yes	Surface Condition? (G/P)	Good

**Remove & Replace Curb Ramp With Two New Directional Ramps or Equivalent.**
