Access Compliance Report Public Rights-of-Way (Curb Ramps)

Intersection ID: 29957 Main Street: PANOS DR **Cross Street: SMITH CORNERS BV** Location: NW **Overall Compliance: No Severity Score:** 25 ADA ID: 7A8EB05E8CF3 Ramp Type: BlendTrans1 Initial Pass/Fail: Fail

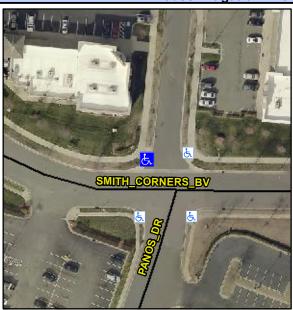
Total Cost: 3200.00 Compliance Description Data Compliance Description Data Yes BlendTrans Slope (%) N/A Ramp Length (in) 93.0 3.6 No Yes Ramp Width (in) 57.0 BlendTrans XSlope (%) 7.4 N/A Flare Type RT N/A Flare Type LT N/A N/A N/A Flare Slope LT (%) N/A N/A Flare Slope RT (%) N/A N/A Flare Traversable LT? N/A N/A Flare Traversable RT? N/A N/A N/A N/A **DWS Provided?** N/A Landing Length (in) N/A Landing Width (in) N/A N/A **DWS Contrast?** N/A N/A N/A N/A Landing Slope (%) DWS Length (in) N/A N/A Landing X Slope (%) N/A N/A DWS Full Width? N/A N/A Landing Curb? (Y/N) N/A N/A DWS Offset (in) N/A N/A N/A Shared Landing? N/A **Gutter Ponding?** N/A N/A Gutter Slope (%) N/A N/A Gutter Lip Ht (in) N/A N/A Gutter X Slope (%) N/A N/A Painted X Walk1? No N/A Painted X Walk2? No X Walk 1 Direction To S X Walk 2 Direction To E N/A X Walk 1 Width (in) X Walk 2 Width (in) N/A X Walk 1 Slope (%) 6.0 X Walk 2 Slope (%) 2.8 X Walk 1 X Slope (%) 1.7 X Walk 2 X Slope (%) 2.6 N/A N/A Ramp inside XWalk2? N/A N/A Ramp inside XWalk1? Road Slope (%) 2.7 Clear Space? N/A Road X Slope (%) 0.3 N/A Clear Space to XWalk (in) N/A N/A N/A N/A Any Obstructions? Storm Grate/Utility Hazard? N/A Obstruction Type Storm Grate/Utility Type N/A N/A Yes Surface Condition? (G/P) Good No Curb Slope (%) 10.3

SMITH CORNERS BV Street 1 Name Stop Condition-Street 1 **PANOS DR** Street 2 Name Stop Condition-Street 2 StopSign Possible Solutions: Remove & Replace Curb Ramp With Two New Directional Ramps or Equivalent. Surveyor Notes: N/A PROW/ADA: Not Found, R304.5.3
