Access Compliance Report

Public Rights-of-Way

(Curb Ramps)

Intersection ID: 47251	Main Street: CRANBERRY_WOODS_CT	Cross Street: RASPBERRY_KNOLL_DR	Location:	N
ADA ID: 7AA385381534	Ramp Type: BlendTrans1	Initial Pass/Fail: Fail	Overall Compliance: No	Severity Score: 8.75
Codes/Mitigation Info/Possible Solution		Field Measurements/Component Compliance

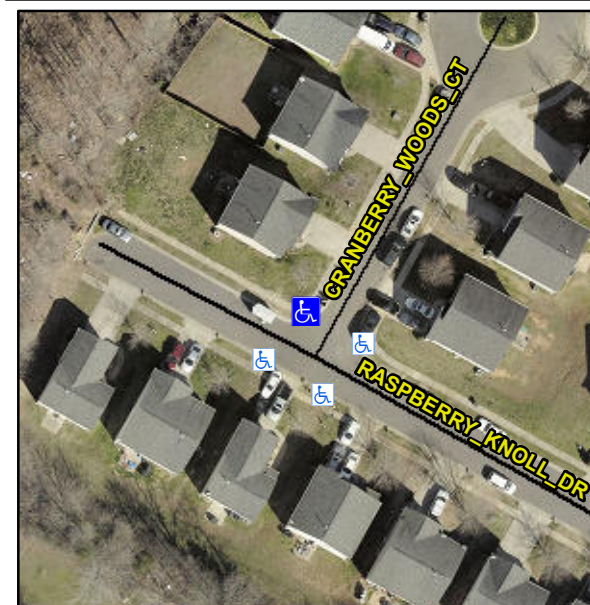
Not Found, R304.5.1

Compliance	Description	Data	Compliance	Description	Data
N/A	Ramp Length (in)	47.0	Yes	BlendTrans Slope (%)	2.5
No	Ramp Width (in)	39.5	Yes	BlendTrans XSlope (%)	1.1
N/A	Flare Type LT	N/A	N/A	Flare Type RT	N/A
N/A	Flare Slope LT (%)	N/A	N/A	Flare Slope RT (%)	N/A
N/A	Flare Traversable LT?	N/A	N/A	Flare Traversable RT?	N/A
N/A	Landing Length (in)	N/A	N/A	DWS Provided?	N/A
N/A	Landing Width (in)	N/A	N/A	DWS Contrast?	N/A
N/A	Landing Slope (%)	N/A	N/A	DWS Length (in)	N/A
N/A	Landing X Slope (%)	N/A	N/A	DWS Full Width?	N/A
N/A	Landing Curb? (Y/N)	N/A	N/A	DWS Offset (in)	N/A
N/A	Shared Landing?	N/A			
N/A	Gutter Ponding?	N/A	N/A	Gutter Slope (%)	N/A
N/A	Gutter Lip Ht (in)	N/A	N/A	Gutter X Slope (%)	N/A
N/A	Painted X Walk1?	No	N/A	Painted X Walk2?	No
	X Walk 1 Direction	To SW		X Walk 2 Direction	To SE
	X Walk 1 Width (in)	N/A		X Walk 2 Width (in)	N/A
	X Walk 1 Slope (%)	3.7		X Walk 2 Slope (%)	4.3
	X Walk 1 X Slope (%)	2.6		X Walk 2 X Slope (%)	7.9

N/A	Ramp inside XWalk1?	N/A	N/A	Ramp inside XWalk2?	N/A
	Road Slope (%)	1.0		Clear Space?	N/A
	Road X Slope (%)	6.0	N/A	Clear Space to XWalk (in)	N/A
N/A	Any Obstructions?	N/A	N/A	Storm Grate/Utility Hazard?	N/A
	Obstruction Type			Storm Grate/Utility Type	
		N/A			N/A
			Yes	Surface Condition? (G/P)	Good
			No	Curb Slope (%)	12.1

Remove & Replace Curb Ramp With Two New Directional Ramps or Equivalent.
