## Access Compliance Report Public Rights-of-Way (Curb Ramps)

Intersection ID: 11741 Main Street: COUNTRY\_CLUB\_DR Cross Street: MATHESON\_AV Location: N

ADA ID: 7AB69AC20EAE Ramp Type: MedianPerp Initial Pass/Fail: Fail Overall Compliance: No Severity Score: 26.25

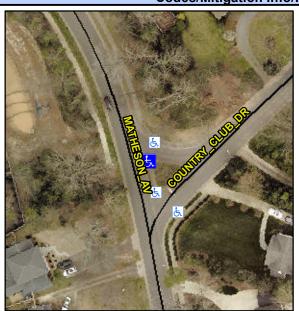
Not Found, R304.2.2, R304.5.3

Compliance Description D		Data	Compliance Description		Data
N/A	Ramp Length (in)	59.0	No	Ramp Slope (%)	16.4
Yes	Ramp Width (in)	49.0	No	Ramp XSlope (%)	2.5
N/A	Flare Type LT	N/A	N/A	Flare Type RT	N/A
N/A	Flare Slope LT (%)	N/A	N/A	Flare Slope RT (%)	N/A
N/A	Flare Traversable LT?	N/A	N/A	Flare Traversable RT?	N/A
N/A	Landing Length (in)	N/A	N/A	DWS Provided?	N/A
N/A	Landing Width (in)	N/A	N/A	DWS Contrast?	N/A
N/A	Landing Slope (%)	N/A	N/A	DWS Length (in)	N/A
N/A	Landing X Slope (%)	N/A	N/A	DWS Full Width?	N/A
N/A	Landing Curb? (Y/N)	N/A	N/A	DWS Offset (in)	N/A
N/A	Shared Landing?	N/A			
N/A	Gutter Ponding?	N/A	N/A	Gutter Slope (%)	N/A
N/A	Gutter Lip Ht (in)	0.5	N/A	Gutter X Slope (%)	N/A
N/A	Painted X Walk1?	No	N/A	Painted X Walk2?	N/A
	X Walk 1 Direction	To N		X Walk 2 Direction	N/A
N/A	X Walk 1 Width (in)	N/A	N/A	X Walk 2 Width (in)	N/A
	X Walk 1 Slope (%)	2.9		X Walk 2 Slope (%)	N/A
	X Walk 1 X Slope (%)	6.0		X Walk 2 X Slope (%)	N/A

Remove & Replace Entire Ramp.

Total Cost: \$ 1650.00
