## Access Compliance Report Public Rights-of-Way (Curb Ramps)

Intersection ID: 13696 Main Street: S\_KINGS\_DR Cross Street: E\_3RD\_ST Location: E

ADA ID: 7AB723B0A1C3 Ramp Type: PerpDiag Initial Pass/Fail: Fail Overall Compliance: No Severity Score: 36.25

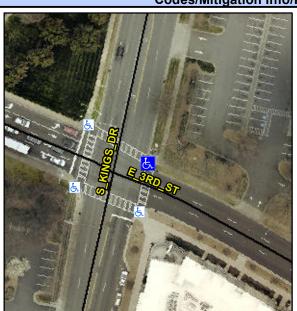
Not Found, R304.5.1, R304.5.3

Compliance Description Da		Data	Comp	liance	Description	Data
N/A	Ramp Length (in)	56.5	Yes	Ram	Slope (%)	6.7
No	Ramp Width (in)	25.5	No	Ram	XSlope (%)	2.6
N/A	Flare Type LT	N/A	N/A	Flare	Type RT	N/A
N/A	Flare Slope LT (%)	N/A	N/A	Flare	Slope RT (%)	N/A
N/A	Flare Traversable LT?	N/A	N/A	Flare	Traversable RT?	N/A
N/A	Landing Length (in)	N/A	N/A	DWS	Provided?	N/A
N/A	Landing Width (in)	N/A	N/A	DWS	Contrast?	N/A
N/A	Landing Slope (%)	N/A	N/A	DWS	Length (in)	N/A
N/A	Landing X Slope (%)	N/A	N/A	DWS	Full Width?	N/A
N/A	Landing Curb? (Y/N)	N/A	N/A	DWS	Offset (in)	N/A
N/A	Shared Landing?	N/A				
N/A	Gutter Ponding?	N/A	N/A	Gutte	er Slope (%)	N/A
N/A	Gutter Lip Ht (in)	N/A	N/A	Gutte	r X Slope (%)	N/A
N/A	Painted X Walk1?	Yes	N/A	Paint	ed X Walk2?	Yes
	X Walk 1 Direction	To NW		X Wa	lk 2 Direction	To SW
N/A	X Walk 1 Width (in)	95.0	N/A	X Wa	lk 2 Width (in)	95.0
	X Walk 1 Slope (%)	3.7		X Wa	lk 2 Slope (%)	1.1
	X Walk 1 X Slope (%)	2.1		X Wa	lk 2 X Slope (%)	1.9

N/A	Ramp inside XWalk1?	Yes	N/A	Ram	inside XWalk2?	Yes
	Road Slope (%)	1.1	N/A	Clear	Space?	N/A
	Road X Slope (%)	4.0	N/A	Clear	Space to XWalk (in)	N/A
N/A	Any Obstructions?	N/A	N/A	Storn	n Grate/Utility Hazard?	N/A
	Obstruction Type			Storn	n Grate/Utility Type	
		N/A				N/A
			Yes	Surfa	ce Condition? (G/P)	Good

Remove & Replace Curb Ramp With
Two New Directional Ramps or
Equivalent.
