# Access Compliance Report

## Public Rights-of-Way

### (Curb Ramps)

| Intersection ID: 8336 | Main Street: INTERURBAN_AV | Cross Street: WILLARD_ST | Location: W |

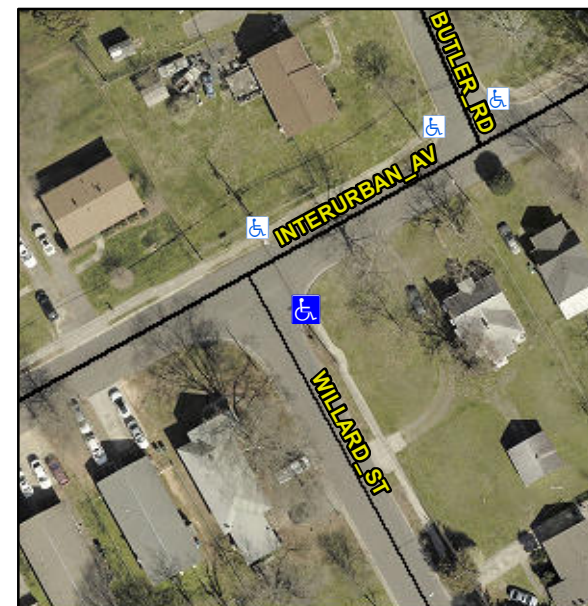
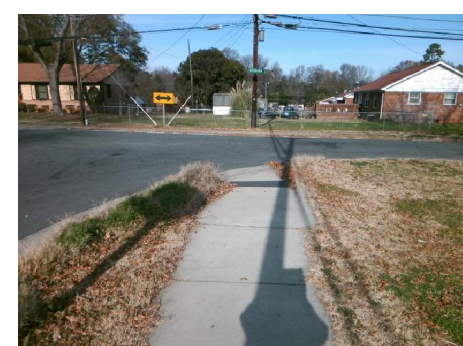
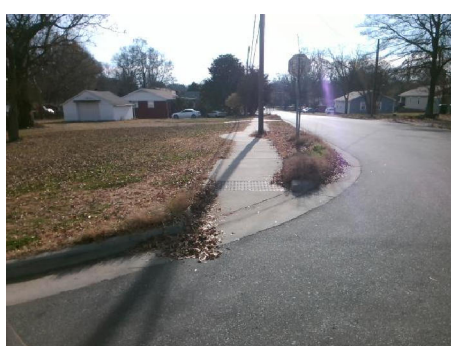
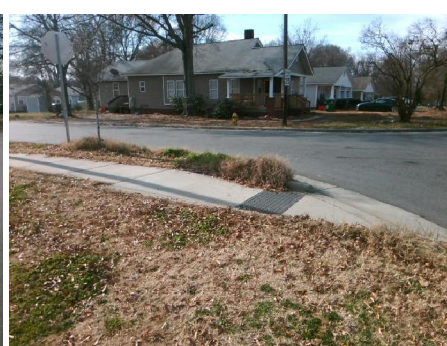
**R305.2**

| Compliance | Description | Data | Compliance | Description | Data |
|---|---|---|---|---|---|
| N/A | Shared Landing? | No | No | DWS Offset RT (in) | 4.0 |

**Remove & Replace Detectable Warning System.**

Total Cost: \$ 800.00
