Access Compliance Report

Public Rights-of-Way

(Curb Ramps)

Intersection ID: 44910	Main Street: FOX_POINT_DR	Cross Street: OAKBURN_DR	Location: W
ADA ID: 7AD75003D60F	Ramp Type: PerpDiag	Initial Pass/Fail: Fail	Overall Compliance: No
Severity Score: 18.75			
Codes/Mitigation Info/Possible Solution		Field Measurements/Component Compliance

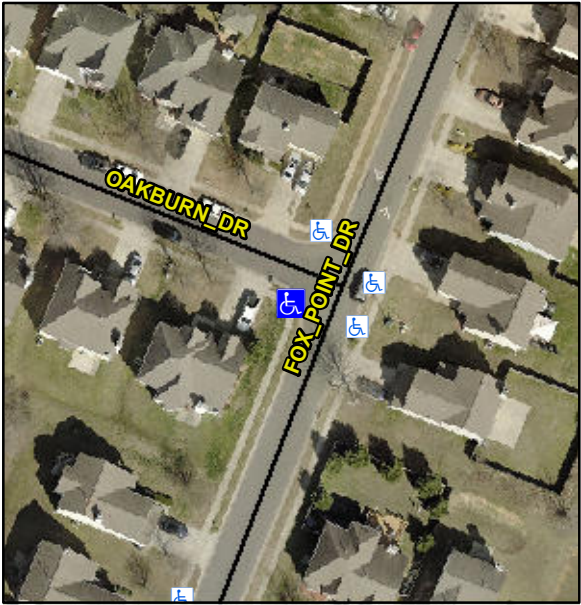
Possible Solutions:	Compliance	Description	Data	Compliance	Description	Data
	Remove & Replace Curb Ramp With Two New Directional Ramps or Equivalent.	N/A	Ramp Length (in)	47.5	Yes	Ramp Slope (%)	5.9
		No	Ramp Width (in)	35.0	No	Ramp XSlope (%)	4.1
		N/A	Flare Type LT	N/A	N/A	Flare Type RT	N/A
		N/A	Flare Slope LT (%)	N/A	N/A	Flare Slope RT (%)	N/A
		N/A	Flare Traversable LT?	N/A	N/A	Flare Traversable RT?	N/A
		N/A	Landing Length (in)	N/A	N/A	DWS Provided?	N/A
		N/A	Landing Width (in)	N/A	N/A	DWS Contrast?	N/A
		N/A	Landing Slope (%)	N/A	N/A	DWS Length (in)	N/A
		N/A	Landing X Slope (%)	N/A	N/A	DWS Full Width?	N/A
<p>Surveyor Notes:</p> <p>N/A</p> <p>PROW/ADA:</p> <p>R304.5.1, R304.5.3</p>		N/A	Landing Curb? (Y/N)	N/A	N/A	DWS Offset (in)	N/A
		N/A	Shared Landing?	N/A			
		N/A	Gutter Ponding?	N/A	N/A	Gutter Slope (%)	N/A
		N/A	Gutter Lip Ht (in)	N/A	N/A	Gutter X Slope (%)	N/A
		N/A	Painted X Walk1?	No	N/A	Painted X Walk2?	No

X Walk 1 Direction	To E		X Walk 2 Direction	To N
		N/A	X Walk 1 Width (in)	N/A	N/A	X Walk 2 Width (in)	N/A
			X Walk 1 Slope (%)	4.3		X Walk 2 Slope (%)	1.1
			X Walk 1 X Slope (%)	1.3		X Walk 2 X Slope (%)	2.6
		N/A	Ramp inside XWalk1?	N/A	N/A	Ramp inside XWalk2?	N/A
<p>Street 1 Name</p> <p>Stop Condition-Street 2</p> <p>Street 2 Name</p> <p>Stop Condition-Street 1</p>			Road Slope (%)	3.3	N/A	Clear Space?	N/A
			Road X Slope (%)	2.0	N/A	Clear Space to XWalk (in)	N/A
		N/A	Any Obstructions?	N/A	N/A	Storm Grate/Utility Hazard?	N/A
			Obstruction Type			Storm Grate/Utility Type	
					N/A		N/A
					Yes	Surface Condition? (G/P)	Good
Total Cost:		\$	3200.00
