Access Compliance Report

Public Rights-of-Way

(Curb Ramps)

Intersection ID: 42368	Main Street: FAIRVISTA_DR	Cross Street: HIGHLAND_CREEK_PY	Location: S
ADA ID: 7AD79EA44490	Ramp Type: PerpDiag	Initial Pass/Fail: Fail	Overall Compliance: No
		Severity Score: 12.5

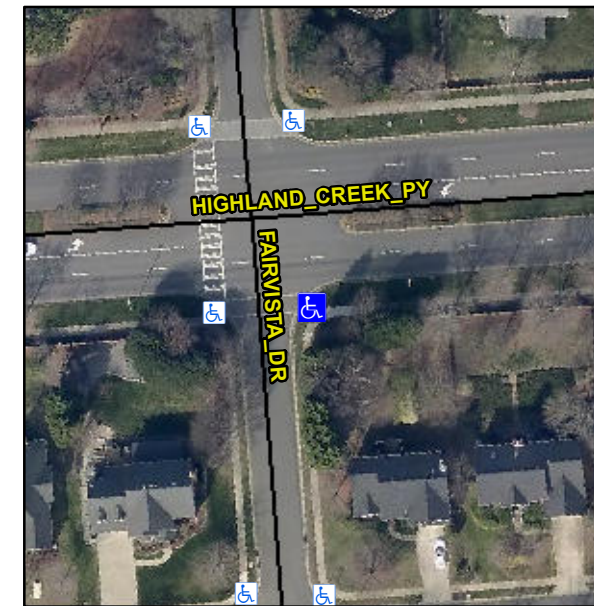
Not Found, R304.5.3

Compliance	Description	Data	Compliance	Description	Data
N/A	Ramp Length (in)	92.0	Yes	Ramp Slope (%)	8.1
Yes	Ramp Width (in)	48.0	No	Ramp XSlope (%)	5.2
N/A	Flare Type LT	N/A	N/A	Flare Type RT	N/A
N/A	Flare Slope LT (%)	N/A	N/A	Flare Slope RT (%)	N/A
N/A	Flare Traversable LT?	N/A	N/A	Flare Traversable RT?	N/A
N/A	Landing Length (in)	N/A	N/A	DWS Provided?	N/A
N/A	Landing Width (in)	N/A	N/A	DWS Contrast?	N/A
N/A	Landing Slope (%)	N/A	N/A	DWS Length (in)	N/A
N/A	Landing X Slope (%)	N/A	N/A	DWS Full Width?	N/A
N/A	Landing Curb? (Y/N)	N/A	N/A	DWS Offset (in)	N/A
N/A	Shared Landing?	N/A			
N/A	Gutter Ponding?	N/A	N/A	Gutter Slope (%)	N/A
N/A	Gutter Lip Ht (in)	1.0	N/A	Gutter X Slope (%)	N/A
N/A	Painted X Walk1?	No	N/A	Painted X Walk2?	No
	X Walk 1 Direction	To N		X Walk 2 Direction	To W
N/A	X Walk 1 Width (in)	N/A	N/A	X Walk 2 Width (in)	N/A
	X Walk 1 Slope (%)	4.1		X Walk 2 Slope (%)	0.9
	X Walk 1 X Slope (%)	1.2		X Walk 2 X Slope (%)	5.9

N/A	Ramp inside XWalk1?	N/A	N/A	Ramp inside XWalk2?	N/A
	Road Slope (%)	6.8	N/A	Clear Space?	N/A
	Road X Slope (%)	5.0	N/A	Clear Space to XWalk (in)	N/A
N/A	Any Obstructions?	N/A	N/A	Storm Grate/Utility Hazard?	N/A
	Obstruction Type			Storm Grate/Utility Type	
		N/A			N/A
		Yes		Surface Condition? (G/P)	Good

Remove & Replace Curb Ramp With Two New Directional Ramps or Equivalent.

Total Cost: \$ 3200.00
