Access Compliance Report

Public Rights-of-Way

(Curb Ramps)

Intersection ID: 30057	Main Street: SOUTHWIND_DR	Cross Street: SUNSET_VILLAGE_DR	Location: S
ADA ID: 7ADCC5D6ED34	Ramp Type: BlendTrans1	Initial Pass/Fail: Fail	Overall Compliance: No
Severity Score: 12.5			
Codes/Mitigation Info/Possible Solution		Field Measurements/Component Compliance

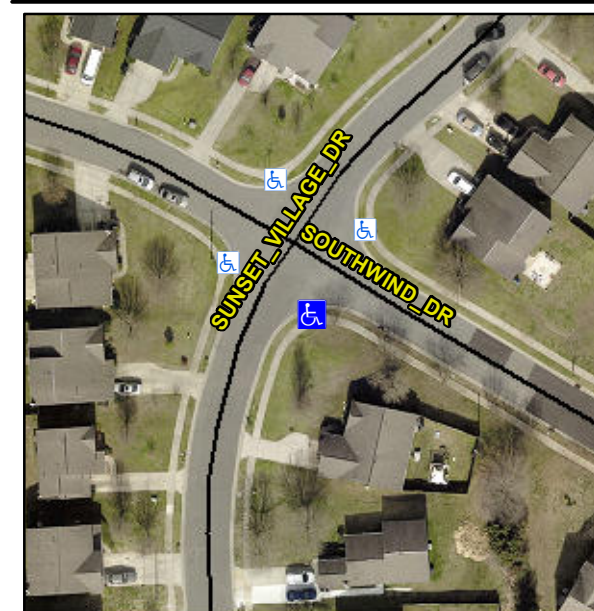
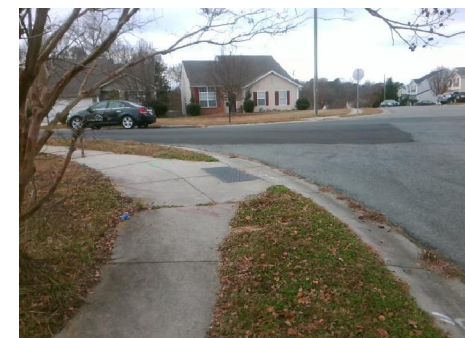
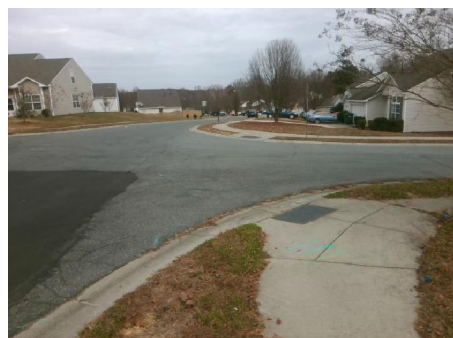
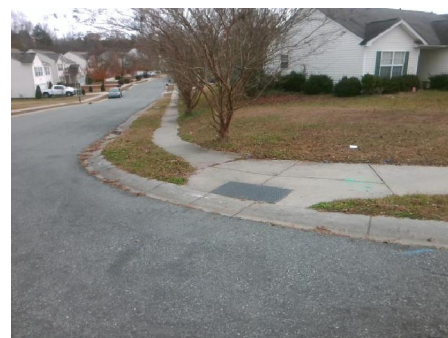
Not Found, R304.5.3

Compliance	Description	Data	Compliance	Description	Data
N/A	Ramp Length (in)	47.0	Yes	BlendTrans Slope (%)	4.8
Yes	Ramp Width (in)	48.0	No	BlendTrans XSlope (%)	6.8
N/A	Flare Type LT	N/A	N/A	Flare Type RT	N/A
N/A	Flare Slope LT (%)	N/A	N/A	Flare Slope RT (%)	N/A
N/A	Flare Traversable LT?	N/A	N/A	Flare Traversable RT?	N/A
N/A	Landing Length (in)	N/A	N/A	DWS Provided?	N/A
N/A	Landing Width (in)	N/A	N/A	DWS Contrast?	N/A
N/A	Landing Slope (%)	N/A	N/A	DWS Length (in)	N/A
N/A	Landing X Slope (%)	N/A	N/A	DWS Full Width?	N/A
N/A	Landing Curb? (Y/N)	N/A	N/A	DWS Offset (in)	N/A
N/A	Shared Landing?	N/A			
N/A	Gutter Ponding?	N/A	N/A	Gutter Slope (%)	N/A
N/A	Gutter Lip Ht (in)	N/A	N/A	Gutter X Slope (%)	N/A
N/A	Painted X Walk1?	No	N/A	Painted X Walk2?	No
	X Walk 1 Direction	To NE		X Walk 2 Direction	To NW
	X Walk 1 Width (in)	N/A		X Walk 2 Width (in)	N/A
	X Walk 1 Slope (%)	1.4		X Walk 2 Slope (%)	6.8
	X Walk 1 X Slope (%)	7.7		X Walk 2 X Slope (%)	0.4

N/A	Ramp inside XWalk1?	N/A	N/A	Ramp inside XWalk2?	N/A
	Road Slope (%)	6.0		Clear Space?	N/A
	Road X Slope (%)	3.4	N/A	Clear Space to XWalk (in)	N/A
N/A	Any Obstructions?	N/A	N/A	Storm Grate/Utility Hazard?	N/A
	Obstruction Type			Storm Grate/Utility Type	
		N/A			N/A
			Yes	Surface Condition? (G/P)	Good
			No	Curb Slope (%)	7.9

Remove & Replace Curb Ramp With Two New Directional Ramps or Equivalent.

Total Cost: \$ 3200.00
