# Access Compliance Report

## Public Rights-of-Way

### (Curb Ramps)

Intersection ID: 11994	Main Street: BELVEDERE_AV	Cross Street: THE_PLAZA	Location: NE
ADA ID: 7AE6931A7BB4	Ramp Type: BlendTrans1	Initial Pass/Fail: Fail	Overall Compliance: No
		Severity Score: 8.75

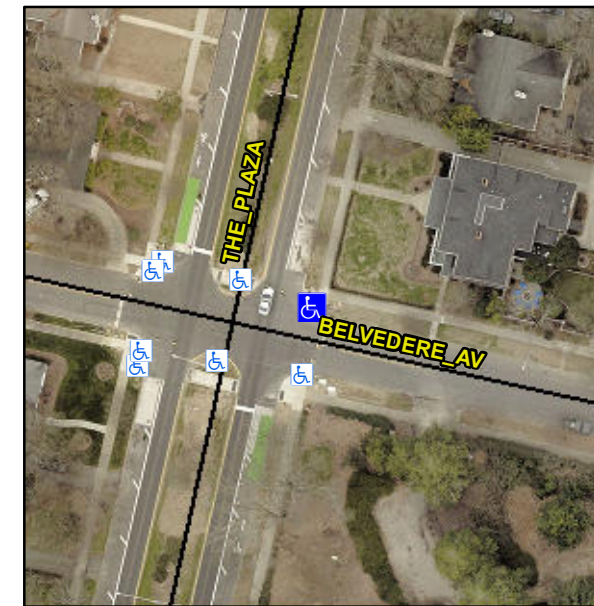
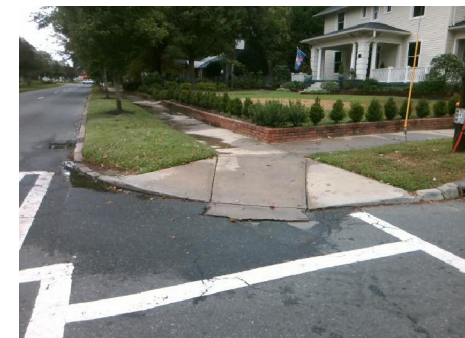
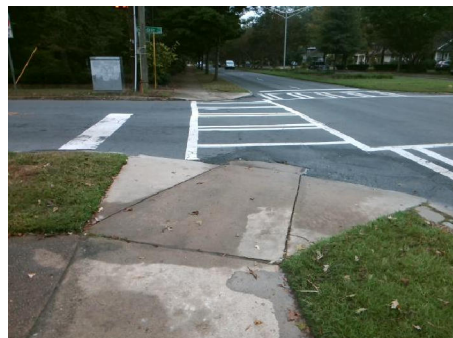
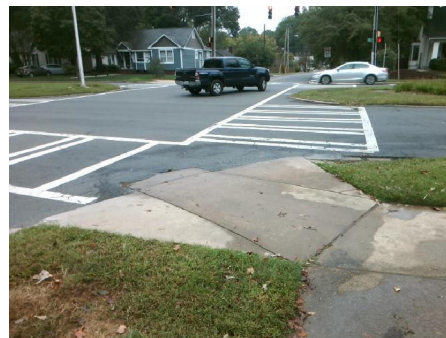
Compliance	Description	Data	Compliance	Description	Data
N/A	Ramp Length (in)	97.0	Yes	BlendTrans Slope (%)	4.7
No	Ramp Width (in)	47.5	Yes	BlendTrans XSlope (%)	0.3
N/A	Flare Type LT	N/A	N/A	Flare Type RT	N/A
N/A	Flare Slope LT (%)	N/A	N/A	Flare Slope RT (%)	N/A
N/A	Flare Traversable LT?	N/A	N/A	Flare Traversable RT?	N/A
N/A	Landing Length (in)	N/A	N/A	DWS Provided?	N/A
N/A	Landing Width (in)	N/A	N/A	DWS Contrast?	N/A
N/A	Landing Slope (%)	N/A	N/A	DWS Length (in)	N/A
N/A	Landing X Slope (%)	N/A	N/A	DWS Full Width?	N/A
N/A	Landing Curb? (Y/N)	N/A	N/A	DWS Offset (in)	N/A
N/A	Shared Landing?	N/A			
N/A	Gutter Ponding?	N/A	N/A	Gutter Slope (%)	N/A
N/A	Gutter Lip Ht (in)	N/A	N/A	Gutter X Slope (%)	N/A
N/A	Painted X Walk1?	Yes	N/A	Painted X Walk2?	Yes
	X Walk 1 Direction	To W		X Walk 2 Direction	To S
	X Walk 1 Width (in)	136.0		X Walk 2 Width (in)	114.0
	X Walk 1 Slope (%)	4.0		X Walk 2 Slope (%)	2.3
	X Walk 1 X Slope (%)	1.5		X Walk 2 X Slope (%)	1.2

N/A	Ramp inside XWalk1?	Yes	N/A	Ramp inside XWalk2?	Yes
	Road Slope (%)	1.4		Clear Space?	N/A
	Road X Slope (%)	1.1	N/A	Clear Space to XWalk (in)	N/A
N/A	Any Obstructions?	N/A	N/A	Storm Grate/Utility Hazard?	N/A
	Obstruction Type			Storm Grate/Utility Type	
		N/A			N/A
		Yes		Surface Condition? (G/P)	Good
		N/A		Curb Slope (%)	2.8

**Remove & Replace Curb Ramp With Two New Directional Ramps or Equivalent.**

**R304.5.1**
