# Access Compliance Report

## Public Rights-of-Way

### (Curb Ramps)

Intersection ID: 7375	Main Street: TRYON_ST	Cross Street: TOM_HUNTER_RD	Location: SE
ADA ID: 7AE7AA2EEC2A	Ramp Type: Directional1	Initial Pass/Fail: Pass	Overall Compliance: No
		Severity Score: 0

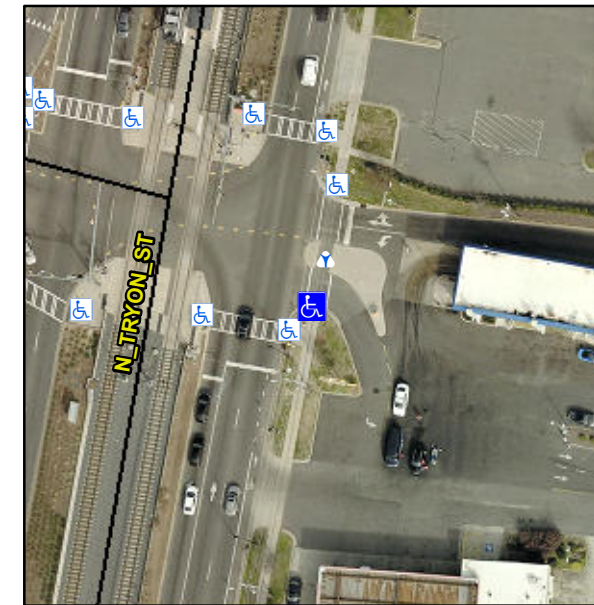
Compliance	Description	Data	Compliance	Description	Data
N/A	Ramp Length (in)	98.0	No	Grade Break?	No
Yes	Ramp Width (in)	68.0	N/A	Grade Break Slope (%)	N/A
Yes	Ramp Slope (%)	3.3	N/A	Grade Break XSlope (%)	N/A
Yes	Ramp XSlope (%)	2.0			
Yes	Flare Type LT	N/A	Yes	Flare Type RT	N/A
N/A	Flare Slope LT (%)	N/A	N/A	Flare Slope RT (%)	N/A
N/A	Flare Traversable LT?	No	N/A	Flare Traversable RT?	No
Yes	Landing Length (in)	48.0	Yes	DWS Provided?	Yes
Yes	Landing Width (in)	71.0	Yes	DWS Contrast?	Yes
Yes	Landing Slope (%)	0.6	Yes	DWS Length (in)	24.0
Yes	Landing X Slope (%)	2.0	Yes	DWS Full Width?	Yes
N/A	Landing Curb? (Y/N)	N/A	No	DWS Offset LT (in)	3.0
N/A	Shared Landing?	Yes	Yes	DWS Offset RT (in)	3.0
Yes	Gutter Ponding?	No	Yes	Gutter Slope (%)	1.0
Yes	Gutter Lip Ht (in)	0.0	Yes	Gutter X Slope (%)	0.5
N/A	Painted X Walk1?	Yes		Road Slope (%)	1.8
	X Walk 1 Direction	To N		Road X Slope (%)	2.8
	X Walk 1 Width (in)	120.0		Clear Space?	Yes

X Walk 1 Slope (%)	1.8	N/A	Clear Space to XWalk (in)	N/A
	X Walk 1 X Slope (%)	2.8	Yes	Storm Grate/Utility Hazard?	No
Yes	Ramp inside XWalk1?	Yes		Storm Grate/Utility Type	
Yes	Any Obstructions?	No			N/A
	Obstruction Type		Yes	Surface Condition? (G/P)	Good
			N/A	Curb Slope (%)	6.3

Possible Solutions:

**Remove & Replace Entire Ramp.**

**R304.5.2, R305.2**
