# Access Compliance Report

## Public Rights-of-Way

### (Curb Ramps)

Intersection ID: 16359	Main Street: FREELAND_LN	Cross Street: SOUTH_BV	Location: SW
ADA ID: 7AED0B64A01B	Ramp Type: Directional1	Initial Pass/Fail: Fail	Overall Compliance: No
			Severity Score: 13.75

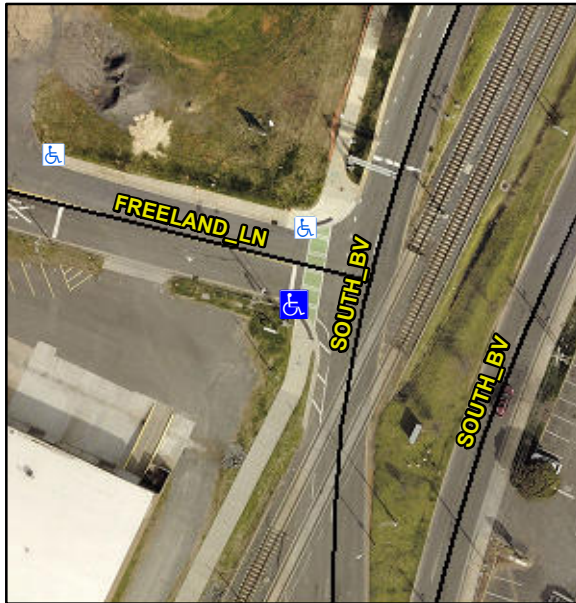
Compliance	Description	Data	Compliance	Description	Data
N/A	Ramp Length (in)	<b>62.0</b>	N/A	Grade Break?	<b>N/A</b>
Yes	Ramp Width (in)	<b>131.0</b>	N/A	Grade Break Slope (%)	<b>0.0</b>
No	Ramp Slope (%)	<b>9.3</b>	N/A	Grade Break XSlope (%)	<b>0.0</b>
No	Ramp XSlope (%)	<b>4.0</b>			
N/A	Flare Type LT	<b>N/A</b>	N/A	Flare Type RT	<b>N/A</b>
N/A	Flare Slope LT (%)	<b>N/A</b>	N/A	Flare Slope RT (%)	<b>0.0</b>
N/A	Flare Traversable LT?	<b>N/A</b>	N/A	Flare Traversable RT?	<b>N/A</b>
N/A	Landing Length (in)	<b>0.0</b>	N/A	DWS Provided?	<b>N/A</b>
N/A	Landing Width (in)	<b>0.0</b>	N/A	DWS Contrast?	<b>N/A</b>
N/A	Landing Slope (%)	<b>0.0</b>	N/A	DWS Length (in)	<b>N/A</b>
N/A	Landing X Slope (%)	<b>0.0</b>	N/A	DWS Full Width?	<b>N/A</b>
N/A	Landing Curb? (Y/N)	<b>N/A</b>	N/A	DWS Offset LT (in)	<b>N/A</b>
N/A	Shared Landing?	<b>N/A</b>	N/A	DWS Offset RT (in)	<b>N/A</b>
N/A	Gutter Ponding?	<b>0.0</b>	N/A	Gutter Slope (%)	<b>N/A</b>

N/A	Gutter Lip Ht (in)	<b>0.0</b>	N/A	Gutter X Slope (%)	<b>N/A</b>
N/A	Painted X Walk1?	<b>Yes</b>		Road Slope (%)	<b>2.3</b>
	X Walk 1 Direction	<b>To N</b>		Road X Slope (%)	<b>1.4</b>
	X Walk 1 Width (in)	<b>108.0</b>		Clear Space?	<b>N/A</b>
	X Walk 1 Slope (%)	<b>2.3</b>	N/A	Clear Space to XWalk (in)	<b>N/A</b>
	X Walk 1 X Slope (%)	<b>1.4</b>	N/A	Storm Grate/Utility Hazard?	<b>N/A</b>
N/A	Ramp inside XWalk1?	<b>Yes</b>		Storm Grate/Utility Type	
N/A	Any Obstructions?	<b>N/A</b>			<b>N/A</b>
	Obstruction Type		Yes	Surface Condition? (G/P)	<b>Good</b>
			N/A	Curb Slope (%)	<b>4.4</b>

**Remove & Replace Entire Ramp.**

**R304.2.2, R304.5.3**

Total Cost: \$ **1600.00**
