# Access Compliance Report

## Public Rights-of-Way

### (Curb Ramps)

Intersection ID: 19907	Main Street: SEDLEY_RD	Cross Street: FOXCROFT_RD	Location: SE
ADA ID: 7AED73E6D08F	Ramp Type: PerpDiag	Initial Pass/Fail: Fail	Overall Compliance: No
		Severity Score: 13.75

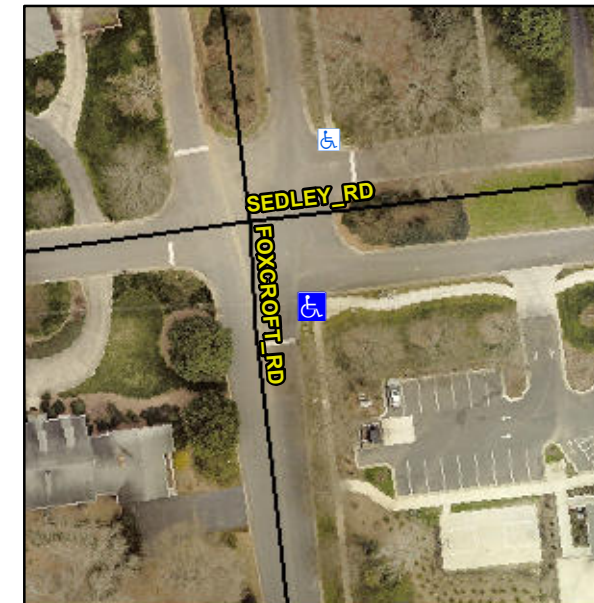
**Not Found, R304.2.2, R304.5.3**

Compliance	Description	Data	Compliance	Description	Data
N/A	Ramp Length (in)	63.0	No	Ramp Slope (%)	10.4
Yes	Ramp Width (in)	48.0	No	Ramp XSlope (%)	2.8
N/A	Flare Type LT	N/A	N/A	Flare Type RT	N/A
N/A	Flare Slope LT (%)	N/A	N/A	Flare Slope RT (%)	N/A
N/A	Flare Traversable LT?	N/A	N/A	Flare Traversable RT?	N/A
N/A	Landing Length (in)	N/A	N/A	DWS Provided?	N/A
N/A	Landing Width (in)	N/A	N/A	DWS Contrast?	N/A
N/A	Landing Slope (%)	N/A	N/A	DWS Length (in)	N/A
N/A	Landing X Slope (%)	N/A	N/A	DWS Full Width?	N/A
N/A	Landing Curb? (Y/N)	N/A	N/A	DWS Offset (in)	N/A
N/A	Shared Landing?	N/A			
N/A	Gutter Ponding?	N/A	N/A	Gutter Slope (%)	N/A
N/A	Gutter Lip Ht (in)	N/A	N/A	Gutter X Slope (%)	N/A
N/A	Painted X Walk1?	No	N/A	Painted X Walk2?	No
	X Walk 1 Direction	To N		X Walk 2 Direction	To W
N/A	X Walk 1 Width (in)	N/A	N/A	X Walk 2 Width (in)	N/A
	X Walk 1 Slope (%)	2.7		X Walk 2 Slope (%)	0.2
	X Walk 1 X Slope (%)	0.7		X Walk 2 X Slope (%)	2.0

N/A	Ramp inside XWalk1?	N/A	N/A	Ramp inside XWalk2?	N/A
	Road Slope (%)	0.4	N/A	Clear Space?	N/A
	Road X Slope (%)	1.1	N/A	Clear Space to XWalk (in)	N/A
N/A	Any Obstructions?	N/A	N/A	Storm Grate/Utility Hazard?	N/A
	Obstruction Type			Storm Grate/Utility Type	
		N/A			N/A
		Yes		Surface Condition? (G/P)	Good

**Remove & Replace Curb Ramp With Two New Directional Ramps or Equivalent.**
