Access Compliance Report

Public Rights-of-Way

(Curb Ramps)

Intersection ID: 13682	Main Street: E_8TH_ST	Cross Street: LAMAR_AV	Location: W
ADA ID: 7AF2594F21C4	Ramp Type: BlendTrans1	Initial Pass/Fail: Fail	Overall Compliance: No
		Severity Score: 8.75

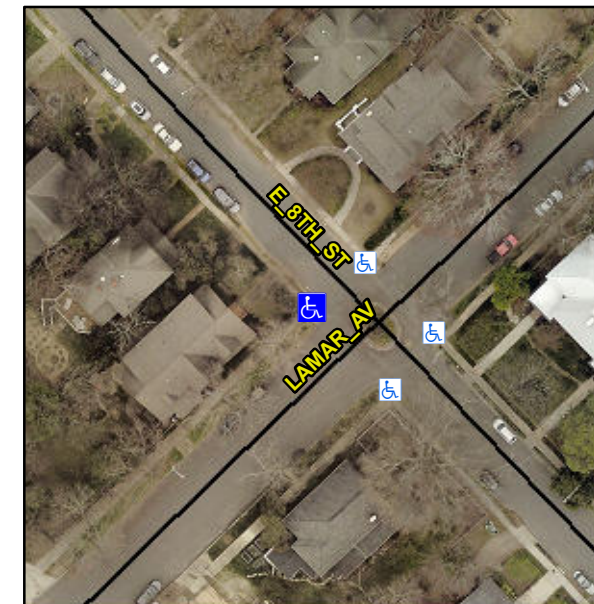
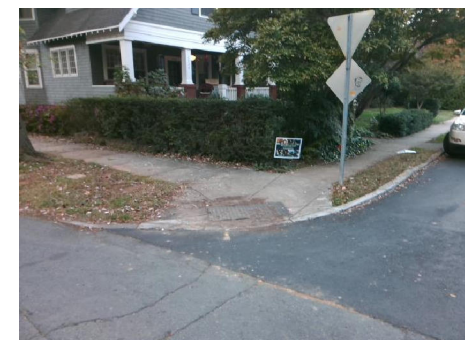
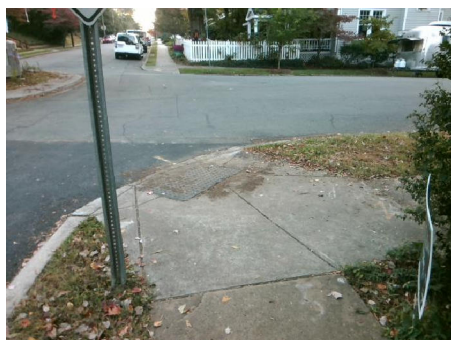
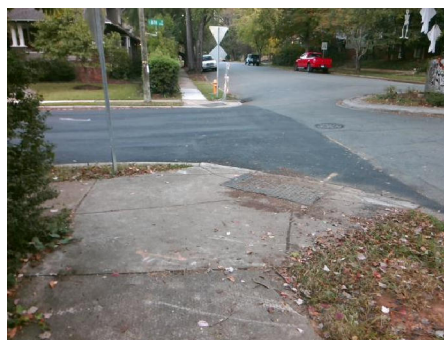
Compliance	Description	Data	Compliance	Description	Data
N/A	Ramp Length (in)	89.0	Yes	BlendTrans Slope (%)	4.1
No	Ramp Width (in)	40.0	Yes	BlendTrans XSlope (%)	2.0
N/A	Flare Type LT	N/A	N/A	Flare Type RT	N/A
N/A	Flare Slope LT (%)	N/A	N/A	Flare Slope RT (%)	N/A
N/A	Flare Traversable LT?	N/A	N/A	Flare Traversable RT?	N/A
N/A	Landing Length (in)	N/A	N/A	DWS Provided?	N/A
N/A	Landing Width (in)	N/A	N/A	DWS Contrast?	N/A
N/A	Landing Slope (%)	N/A	N/A	DWS Length (in)	N/A
N/A	Landing X Slope (%)	N/A	N/A	DWS Full Width?	N/A
N/A	Landing Curb? (Y/N)	N/A	N/A	DWS Offset (in)	N/A
N/A	Shared Landing?	N/A			
N/A	Gutter Ponding?	Yes	N/A	Gutter Slope (%)	N/A
N/A	Gutter Lip Ht (in)	N/A	N/A	Gutter X Slope (%)	N/A
N/A	Painted X Walk1?	No	N/A	Painted X Walk2?	No
	X Walk 1 Direction	To SE		X Walk 2 Direction	To NE
	X Walk 1 Width (in)	N/A		X Walk 2 Width (in)	N/A
	X Walk 1 Slope (%)	12.2		X Walk 2 Slope (%)	7.3
	X Walk 1 X Slope (%)	2.1		X Walk 2 X Slope (%)	4.1

N/A	Ramp inside XWalk1?	N/A	N/A	Ramp inside XWalk2?	N/A
	Road Slope (%)	7.8		Clear Space?	N/A
	Road X Slope (%)	9.9	N/A	Clear Space to XWalk (in)	N/A
N/A	Any Obstructions?	N/A	N/A	Storm Grate/Utility Hazard?	N/A
	Obstruction Type			Storm Grate/Utility Type	
		N/A			N/A
			Yes	Surface Condition? (G/P)	Good
			N/A	Curb Slope (%)	1.4

Remove & Replace Curb Ramp With Two New Directional Ramps or Equivalent.
