# Access Compliance Report

## Public Rights-of-Way

### (Curb Ramps)

| Intersection ID: 31704 | Main Street: ATLAS_CEDAR_DR | Cross Street: DEODORA_CEDAR_LN | Location: E |

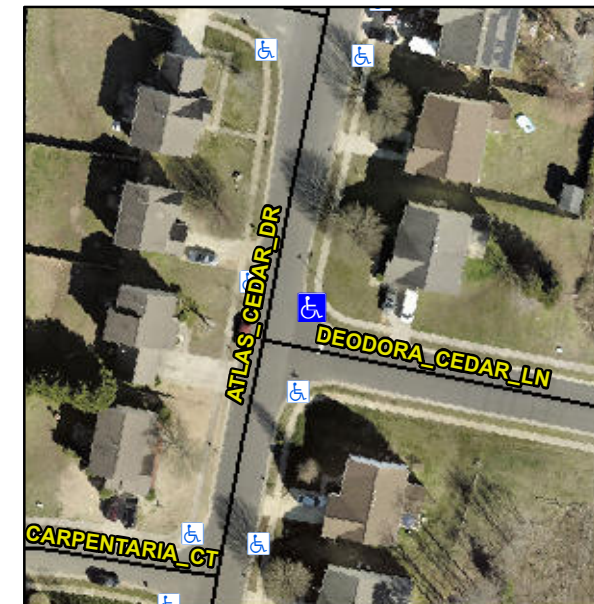
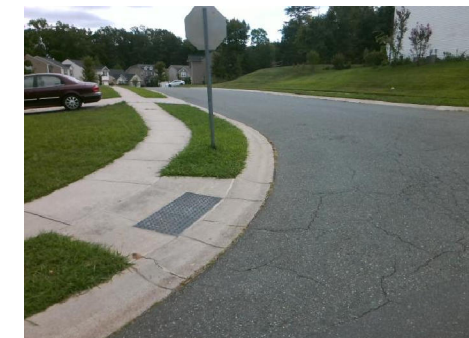
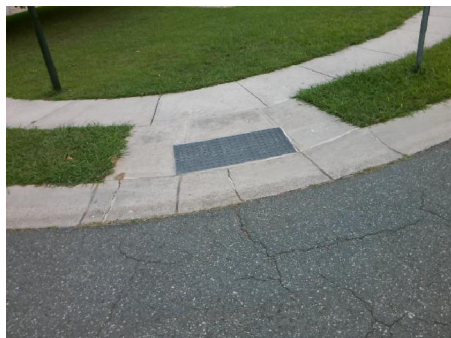
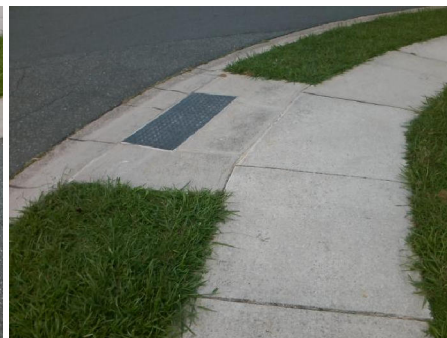
| ADA ID: 7AF6DF405F39 | Ramp Type: PerpDiag | Initial Pass/Fail: Fail | Overall Compliance: No |
| | | Severity Score: 30 | |

**Not Found, R304.5.1, R304.5.3**

| Compliance | Description | Data | Compliance | Description | Data |
|---|---|---|---|---|---|
| N/A | Ramp Length (in) | 49.5 | Yes | Ramp Slope (%) | 6.6 |
| No | Ramp Width (in) | 35.5 | No | Ramp XSlope (%) | 6.4 |

**Remove & Replace Curb Ramp With Two New Directional Ramps or Equivalent.**

Total Cost: \$ 3200.00
