# Access Compliance Report

## Public Rights-of-Way

### (Curb Ramps)

Intersection ID: 1001741	Main Street: FLAT_RIVER_DR	Cross Street: OVERLAND_PARK_LN	Location: E
ADA ID: 7B02A32E7B8D	Ramp Type: Perp	Initial Pass/Fail: Fail	Overall Compliance: No
		Severity Score: 25

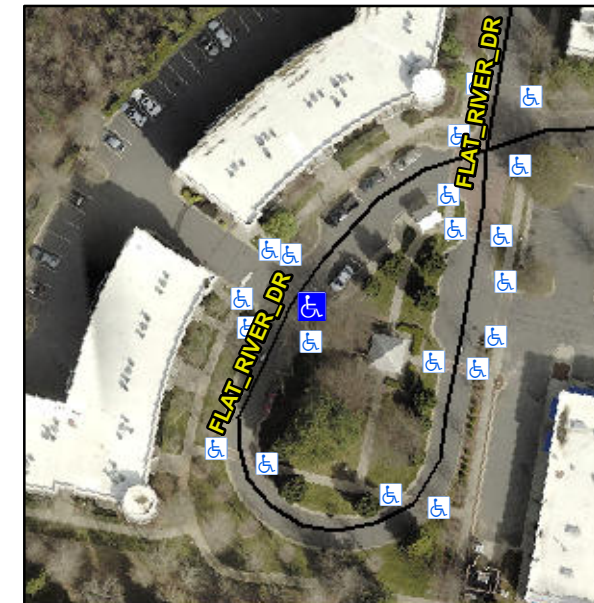
**R304.2.2**

Compliance	Description	Data	Compliance	Description	Data
N/A	Ramp Length (in)	65.5	No	Ramp Slope (%)	16.7
Yes	Ramp Width (in)	53.5	Yes	Ramp XSlope (%)	1.3
N/A	Flare Type LT	N/A	N/A	Flare Type RT	N/A
N/A	Flare Slope LT (%)	N/A	N/A	Flare Slope RT (%)	N/A
N/A	Flare Traversable LT?	N/A	N/A	Flare Traversable RT?	N/A
N/A	Landing Length (in)	N/A	N/A	DWS Provided?	N/A
N/A	Landing Width (in)	N/A	N/A	DWS Contrast?	N/A
N/A	Landing Slope (%)	N/A	N/A	DWS Length (in)	N/A
N/A	Landing X Slope (%)	N/A	N/A	DWS Full Width?	N/A
N/A	Landing Curb? (Y/N)	N/A	N/A	DWS Offset (in)	N/A
N/A	Shared Landing?	N/A			
N/A	Gutter Ponding?	N/A	N/A	Gutter Slope (%)	N/A
N/A	Gutter Lip Ht (in)	N/A	N/A	Gutter X Slope (%)	N/A
N/A	Painted X Walk1?	No	N/A	Painted X Walk2?	N/A
	X Walk 1 Direction	To NW		X Walk 2 Direction	N/A
N/A	X Walk 1 Width (in)	N/A	N/A	X Walk 2 Width (in)	N/A
	X Walk 1 Slope (%)	2.3		X Walk 2 Slope (%)	N/A
	X Walk 1 X Slope (%)	0.2		X Walk 2 X Slope (%)	N/A

N/A	Ramp inside XWalk1?	N/A	N/A	Ramp inside XWalk2?	N/A
	Road Slope (%)	N/A	N/A	Clear Space?	N/A
	Road X Slope (%)	N/A	N/A	Clear Space to XWalk (in)	N/A
N/A	Any Obstructions?	N/A	N/A	Storm Grate/Utility Hazard?	N/A
	Obstruction Type			Storm Grate/Utility Type	
		N/A			N/A
			Yes	Surface Condition? (G/P)	Good

Possible Solutions:

**Remove & Replace Entire Ramp.**

Total Cost: \$ 1850.00
