# Access Compliance Report

## Public Rights-of-Way

### (Curb Ramps)

| Intersection ID: 13714 | Main Street: HANOVER_ST | Cross Street: MCCLINTOCK_RD | Location: SE |

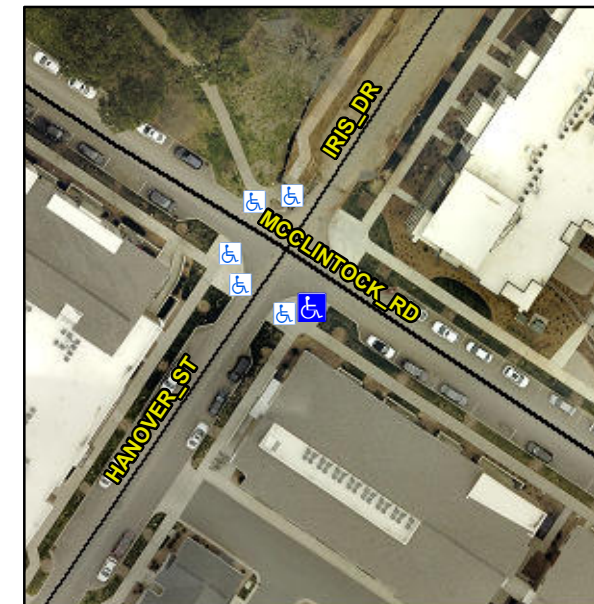
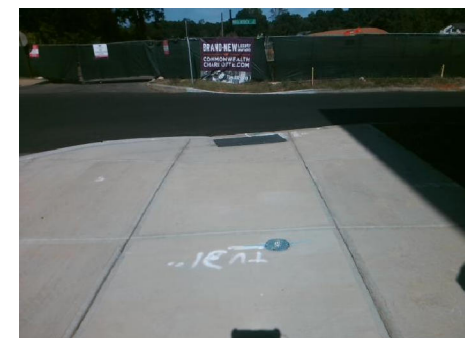
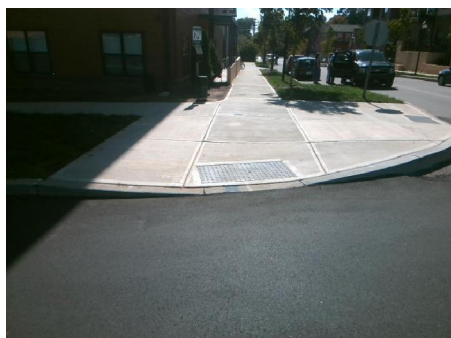
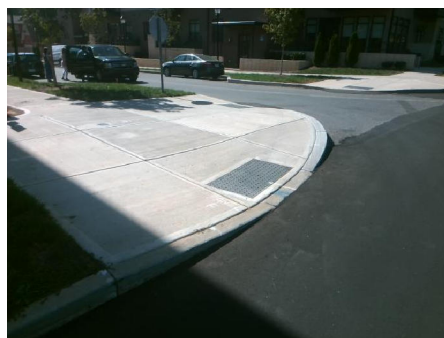
**R304.5.3, R305.1.4, R305.2, R302.7.2**

| Compliance | Description | Data | Compliance | Description | Data |
|---|---|---|---|---|---|
| No | Landing X Slope (%) | 4.0 | No | DWS Full Width? | No |
| No | Gutter Lip Ht (in) | 2.0 | Yes | Gutter X Slope (%) | 1.4 |

**Remove & Replace Curb Ramp With Two New Directional Ramps or Equivalent. Grind Gutter Lip.**
