# Access Compliance Report

## Public Rights-of-Way

| Intersection ID: 19085 | Main Street: REDCOAT_DR | Cross Street: ROCKY_FALLS_RD | Location: E |
| ADA ID: 7B1E4DB94A92 | Ramp Type: BlendTrans2 | Initial Pass/Fail: Pass | Overall Compliance: No |

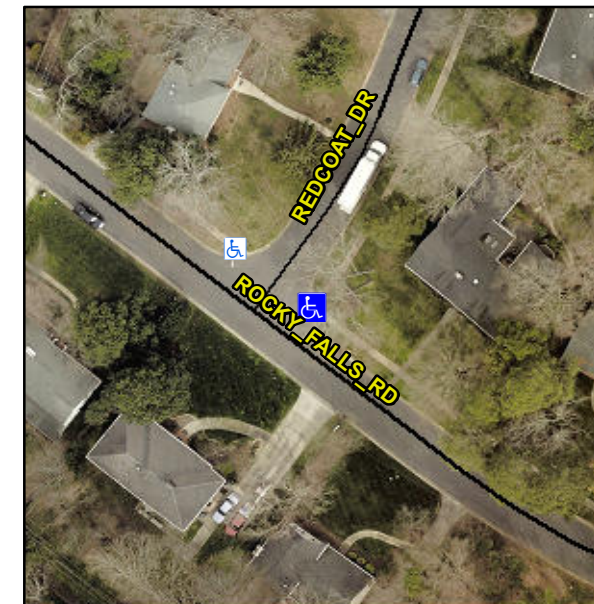
| | | Severity Score: 2.5 | |

**Not Found, R305.1.4, R304.5.3**

| Compliance | Description | Data | Compliance | Description | Data |
|---|---|---|---|---|---|
| N/A | Landing X Slope (%) | N/A | No | DWS Full Width? | No |
| Yes | Gutter Lip Ht (in) | 0.0 | No | Gutter X Slope (%) | 3.3 |

**Remove & Replace Curb Ramp With Two New Directional Ramps or Equivalent. Remove & Replace Gutter.**

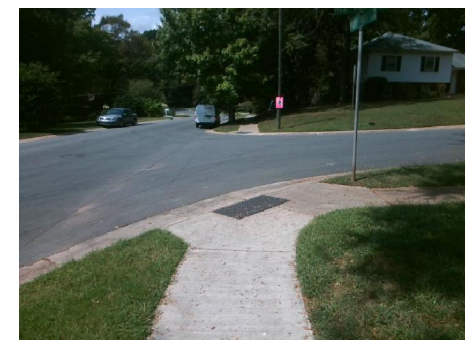
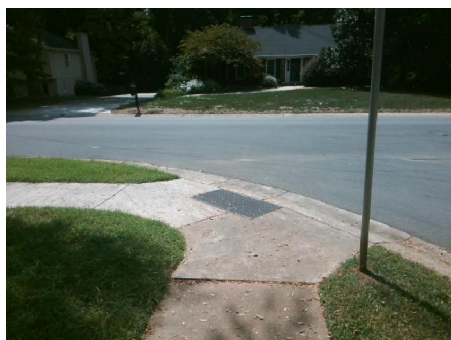
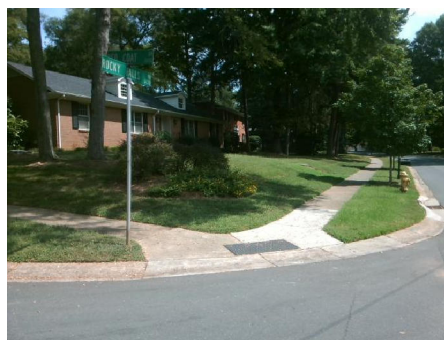
| Compliance | Description | Data | Compliance | Description | Data |
|---|---|---|---|---|---|
| | | | No | Curb Slope (%) | 16.3 |

Total Cost: \$ 3950.00
