Access Compliance Report

Public Rights-of-Way

(Curb Ramps)

Intersection ID: 9708	Main Street: CLIFTON_ST	Cross Street: WASHINGTON_AV	Location:	N
ADA ID: 7B1EB7651F2B	Ramp Type: Perp	Initial Pass/Fail: Pass	Overall Compliance: No	Severity Score: 15

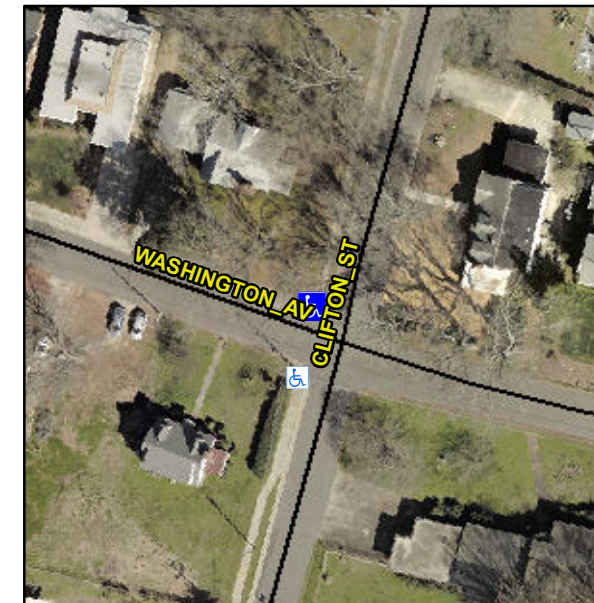
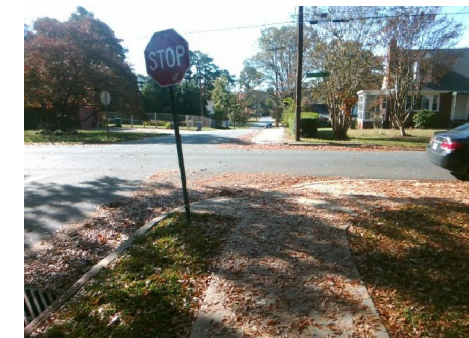
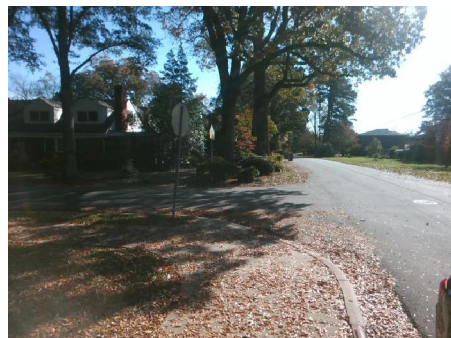
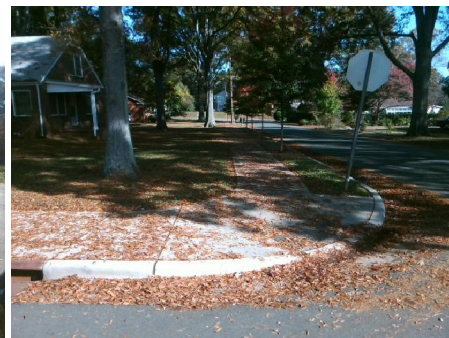
**Not Found, R304.2.1, R304.2.2-Perp,
R304.3.2-Para, R304.5.3, R305.2,
R304.5.4**

Compliance	Description	Data	Compliance	Description	Data
N/A	Ramp Length (in)	96.0	Yes	Ramp Slope (%)	6.0
Yes	Ramp Width (in)	49.0	Yes	Ramp XSlope (%)	1.1
N/A	Flare Type LT	Sloped	N/A	Flare Type RT	N/A
N/A	Flare Slope LT (%)	6.0	Yes	Flare Slope RT (%)	9.7
N/A	Flare Traversable LT?	Yes	N/A	Flare Traversable RT?	Yes
No	Landing Length (in)	N/A	Yes	DWS Provided?	Yes
No	Landing Width (in)	N/A	Yes	DWS Contrast?	Yes
No	Landing Slope (%)	N/A	Yes	DWS Length (in)	24.0
No	Landing X Slope (%)	N/A	Yes	DWS Full Width?	Yes
N/A	Landing Curb? (Y/N)	No	No	DWS Offset (in)	6.0
N/A	Shared Landing?	No			
Yes	Gutter Ponding?	No	No	Gutter Slope (%)	9.6
Yes	Gutter Lip Ht (in)	0.0	Yes	Gutter X Slope (%)	0.3
N/A	Painted X Walk1?	No	N/A	Painted X Walk2?	N/A
	X Walk 1 Direction	To SW		X Walk 2 Direction	N/A
N/A	X Walk 1 Width (in)	N/A	N/A	X Walk 2 Width (in)	N/A
	X Walk 1 Slope (%)	1.1		X Walk 2 Slope (%)	N/A
	X Walk 1 X Slope (%)	1.0		X Walk 2 X Slope (%)	N/A

N/A	Ramp inside XWalk1?	N/A	N/A	Ramp inside XWalk2?	N/A
	Road Slope (%)	N/A	N/A	Clear Space?	Yes
	Road X Slope (%)	N/A	N/A	Clear Space to XWalk (in)	N/A
Yes	Any Obstructions?	No	Yes	Storm Grate/Utility Hazard?	No
	Obstruction Type			Storm Grate/Utility Type	
		N/A			N/A
			Yes	Surface Condition? (G/P)	Good

**Remove & Replace Entire Ramp.
Remove & Replace Gutter.**
