Access Compliance Report

Public Rights-of-Way

(Curb Ramps)

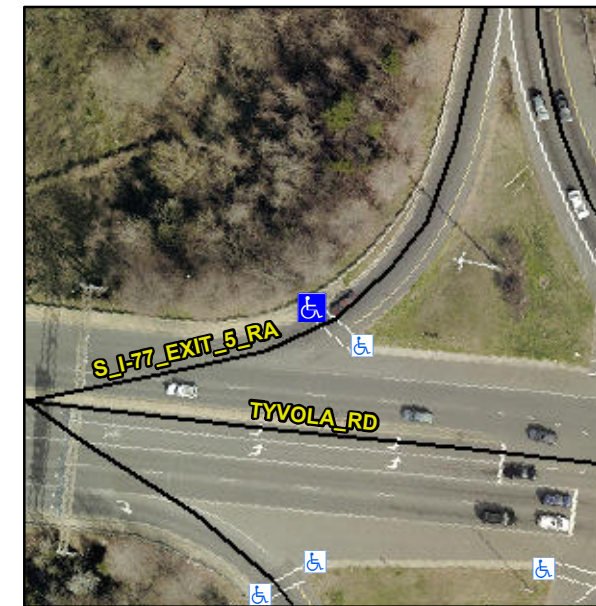
Intersection ID: 18914		Main Street: S_I-77_EXIT_5_RA		Cross Street: TYVOLA_RD		Location:		NE	
ADA ID: 7B1F423B19A2		Ramp Type: Perp		Initial Pass/Fail: Fail		Overall Compliance: No		Severity Score: 10	
Codes/Mitigation Info/Possible Solution					Field Measurements/Component Compliance

Compliance	Description	Data	Compliance	Description	Data
N/A	Ramp Length (in)	62.0	Yes	Ramp Slope (%)	7.7
No	Ramp Width (in)	39.0	No	Ramp XSlope (%)	2.5
N/A	Flare Type LT	N/A	N/A	Flare Type RT	N/A
N/A	Flare Slope LT (%)	N/A	N/A	Flare Slope RT (%)	N/A
N/A	Flare Traversable LT?	N/A	N/A	Flare Traversable RT?	N/A
N/A	Landing Length (in)	N/A	N/A	DWS Provided?	N/A
N/A	Landing Width (in)	N/A	N/A	DWS Contrast?	N/A
N/A	Landing Slope (%)	N/A	N/A	DWS Length (in)	N/A
N/A	Landing X Slope (%)	N/A	N/A	DWS Full Width?	N/A
N/A	Landing Curb? (Y/N)	N/A	N/A	DWS Offset (in)	N/A
N/A	Shared Landing?	N/A			
N/A	Gutter Ponding?	N/A	N/A	Gutter Slope (%)	N/A
N/A	Gutter Lip Ht (in)	N/A	N/A	Gutter X Slope (%)	N/A
N/A	Painted X Walk1?	Yes	N/A	Painted X Walk2?	N/A
	X Walk 1 Direction	To SE		X Walk 2 Direction	N/A
N/A	X Walk 1 Width (in)	83.0	N/A	X Walk 2 Width (in)	N/A
	X Walk 1 Slope (%)	1.2		X Walk 2 Slope (%)	N/A
	X Walk 1 X Slope (%)	2.3		X Walk 2 X Slope (%)	N/A

N/A	Ramp inside XWalk1?	Yes	N/A	Ramp inside XWalk2?	N/A
	Road Slope (%)	N/A	N/A	Clear Space?	N/A
	Road X Slope (%)	N/A	N/A	Clear Space to XWalk (in)	N/A
N/A	Any Obstructions?	N/A	N/A	Storm Grate/Utility Hazard?	N/A
	Obstruction Type			Storm Grate/Utility Type	
		N/A			N/A
			Yes	Surface Condition? (G/P)	Good

Possible Solutions:

Remove & Replace Entire Ramp.

R304.5.1, R304.5.3
