# Access Compliance Report

## Public Rights-of-Way

### (Curb Ramps)

| Intersection ID: 45514 | Main Street: MEADOW_BOTTOM_RD | Cross Street: COTTON_PRESS_RD | Location: E |

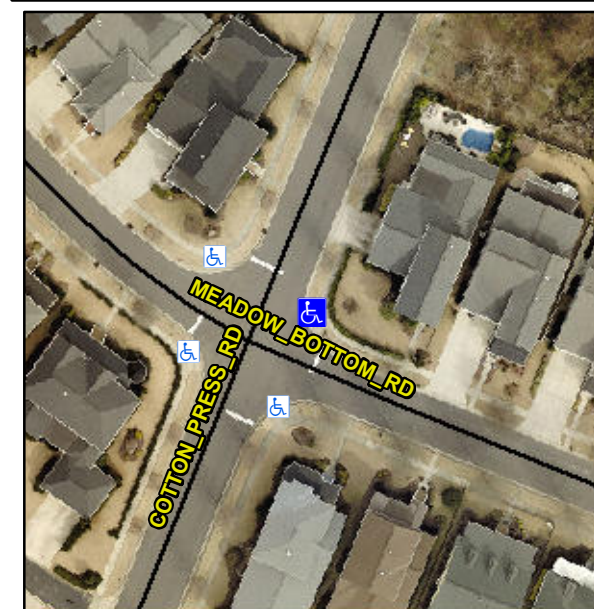
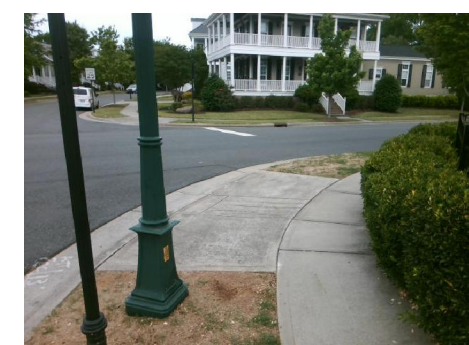
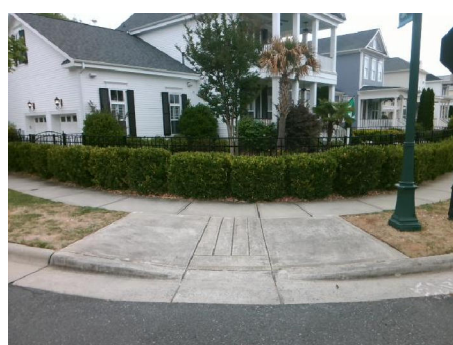
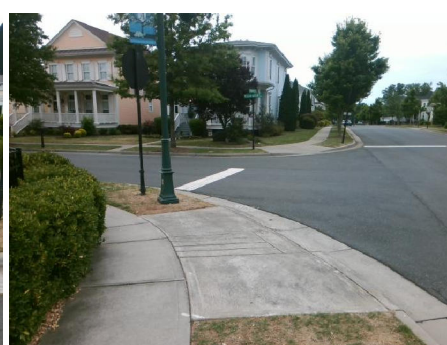
| ADA ID: 7B3895C6464A | Ramp Type: PerpDiag | Initial Pass/Fail: Fail | Overall Compliance: No |

**Not Found, R304.5.1, R304.2.2, R304.5.3**

| Compliance | Description | Data | Compliance | Description | Data |
|---|---|---|---|---|---|
| N/A | Ramp Length (in) | 74.0 | No | Ramp Slope (%) | 9.8 |
| No | Ramp Width (in) | 34.0 | No | Ramp XSlope (%) | 2.7 |

**Remove & Replace Curb Ramp With Two New Directional Ramps or Equivalent.**
