# Access Compliance Report

## Public Rights-of-Way

### (Curb Ramps)

| Intersection ID: 14431 | Main Street: N_COLONIAL_AV | Cross Street: RANDOLPH_RD | Location: SW |

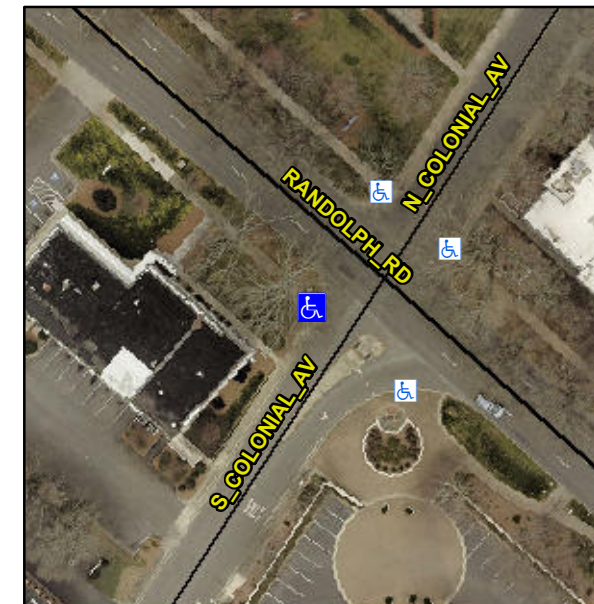
| ADA ID: 7B423ADAF421 | Ramp Type: PerpDiag | Initial Pass/Fail: Pass | Overall Compliance: No |
| | | Severity Score: 12.5 | |

**Not Found, R304.2.1, R304.2.2-Perp, R304.3.2-Para, R304.5.3, R305.1.4, R305.2**

| Compliance | Description | Data | Compliance | Description | Data |
|---|---|---|---|---|---|
| No | Landing Length (in) | N/A | Yes | DWS Provided? | Yes |
| No | Landing X Slope (%) | N/A | No | DWS Full Width? | No |
| Yes | Gutter Lip Ht (in) | 0.0 | No | Gutter X Slope (%) | 2.1 |

**Remove & Replace Curb Ramp With Two New Directional Ramps or Equivalent. Remove & Replace Gutter.**

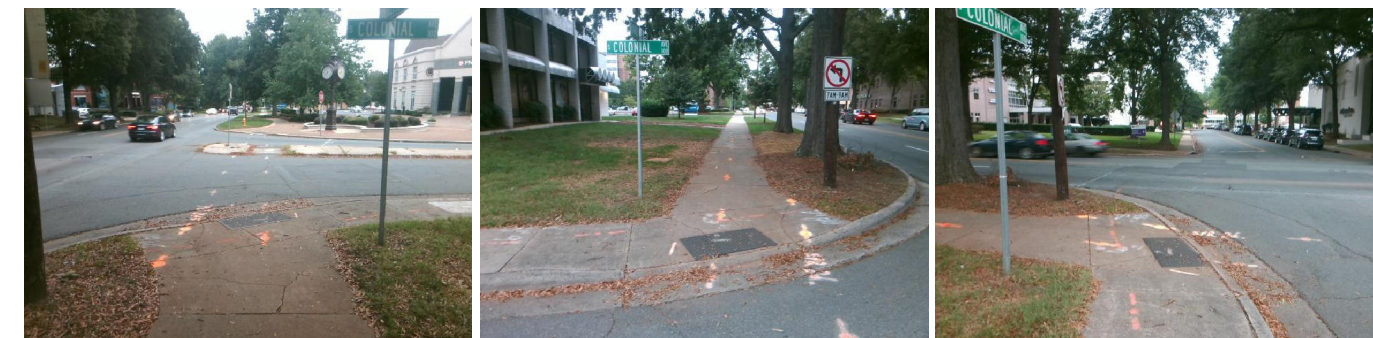
Street 1 Name S COLONIAL AV  
 Stop Condition-Street 2 StopSign  
 Street 2 Name RANDOLPH RD  
 Stop Condition-Street 1 None
