# Access Compliance Report

## Public Rights-of-Way

### (Curb Ramps)

Intersection ID: 5966	Main Street: SUNSTONE_DR	Cross Street: STATESVILLE_RD	Location: NE
ADA ID: 7B4D52265FEC	Ramp Type: Perp	Initial Pass/Fail: Pass	Overall Compliance: No
Severity Score: 15			
Codes/Mitigation Info/Possible Solution		Field Measurements/Component Compliance

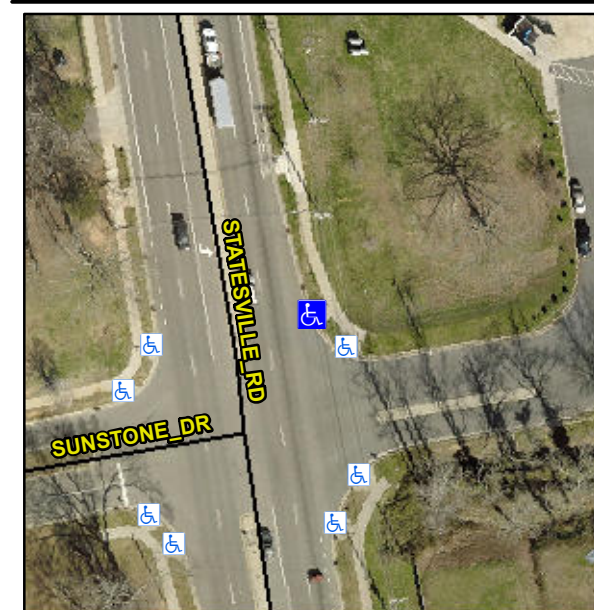
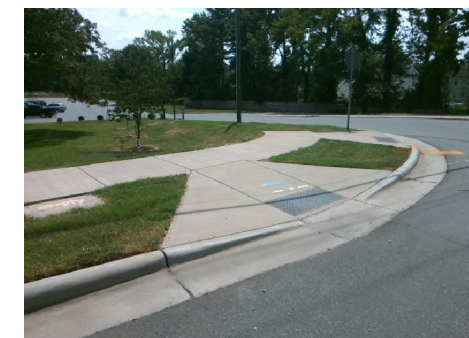
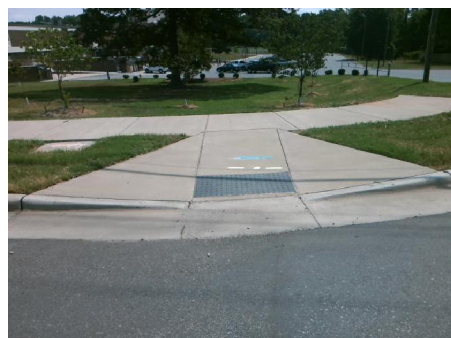
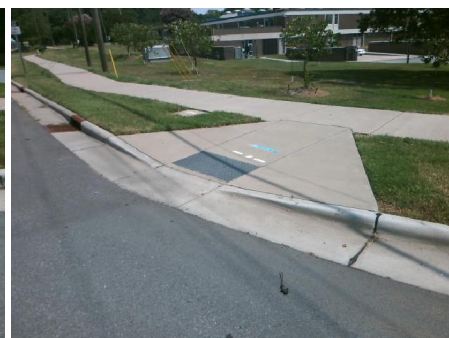
Compliance	Description	Data	Compliance	Description	Data
N/A	Ramp Length (in)	105.5	Yes	Ramp Slope (%)	8.0
Yes	Ramp Width (in)	48.0	Yes	Ramp XSlope (%)	0.1
N/A	Flare Type LT	Sloped	N/A	Flare Type RT	N/A
N/A	Flare Slope LT (%)	5.7	N/A	Flare Slope RT (%)	5.5
N/A	Flare Traversable LT?	No	N/A	Flare Traversable RT?	No
Yes	Landing Length (in)	63.5	Yes	DWS Provided?	Yes
Yes	Landing Width (in)	51.0	Yes	DWS Contrast?	Yes
Yes	Landing Slope (%)	0.8	Yes	DWS Length (in)	24.0
Yes	Landing X Slope (%)	1.0	Yes	DWS Full Width?	Yes
N/A	Landing Curb? (Y/N)	No	No	DWS Offset (in)	3.5
N/A	Shared Landing?	No			
No	Gutter Ponding?	Yes	Yes	Gutter Slope (%)	1.4
No	Gutter Lip Ht (in)	1.0	Yes	Gutter X Slope (%)	0.4
N/A	Painted X Walk1?	No	N/A	Painted X Walk2?	N/A
	X Walk 1 Direction	To W		X Walk 2 Direction	N/A
N/A	X Walk 1 Width (in)	N/A	N/A	X Walk 2 Width (in)	N/A
	X Walk 1 Slope (%)	3.8		X Walk 2 Slope (%)	N/A
	X Walk 1 X Slope (%)	0.7		X Walk 2 X Slope (%)	N/A

N/A	Ramp inside XWalk1?	N/A	N/A	Ramp inside XWalk2?	N/A
	Road Slope (%)	N/A	N/A	Clear Space?	Yes
	Road X Slope (%)	N/A	N/A	Clear Space to XWalk (in)	N/A
Yes	Any Obstructions?	No	Yes	Storm Grate/Utility Hazard?	No
	Obstruction Type			Storm Grate/Utility Type	
		N/A			N/A
			Yes	Surface Condition? (G/P)	Good

Possible Solutions:

**Remove & Replace Detectable Warning System. Grind Gutter Lip.**

**R305.2, R302.7, R302.7.2**

Total Cost: \$ 1000.00
