Access Compliance Report

Public Rights-of-Way

(Curb Ramps)

Intersection ID: 3123	Main Street: GROSBEAK_LN	Cross Street: LITTLE_STONEY_CT	Location: SW
ADA ID: 7B53B3D62656	Ramp Type: Perp	Initial Pass/Fail: Fail	Overall Compliance: No
Severity Score: 25			
Codes/Mitigation Info/Possible Solution		Field Measurements/Component Compliance

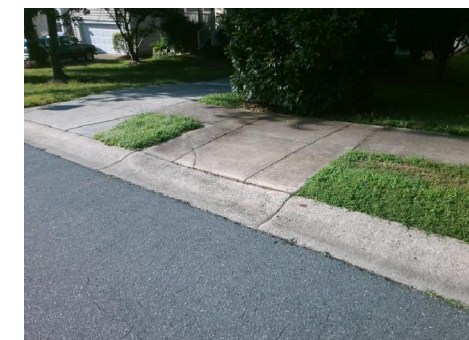
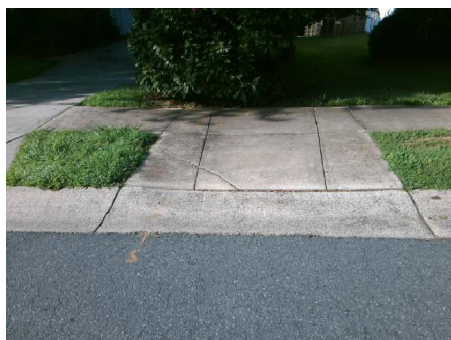
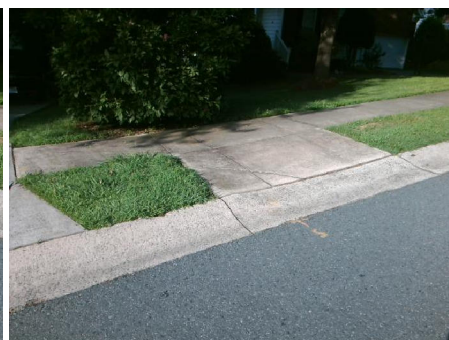
Not Found, R304.5.3

Compliance	Description	Data	Compliance	Description	Data
N/A	Ramp Length (in)	51.0	Yes	Ramp Slope (%)	5.5
Yes	Ramp Width (in)	48.0	No	Ramp XSlope (%)	9.3
N/A	Flare Type LT	N/A	N/A	Flare Type RT	N/A
N/A	Flare Slope LT (%)	N/A	N/A	Flare Slope RT (%)	N/A
N/A	Flare Traversable LT?	N/A	N/A	Flare Traversable RT?	N/A
N/A	Landing Length (in)	N/A	N/A	DWS Provided?	N/A
N/A	Landing Width (in)	N/A	N/A	DWS Contrast?	N/A
N/A	Landing Slope (%)	N/A	N/A	DWS Length (in)	N/A
N/A	Landing X Slope (%)	N/A	N/A	DWS Full Width?	N/A
N/A	Landing Curb? (Y/N)	N/A	N/A	DWS Offset (in)	N/A
N/A	Shared Landing?	N/A			
N/A	Gutter Ponding?	N/A	N/A	Gutter Slope (%)	N/A
N/A	Gutter Lip Ht (in)	N/A	N/A	Gutter X Slope (%)	N/A
N/A	Painted X Walk1?	No	N/A	Painted X Walk2?	N/A
	X Walk 1 Direction	To N		X Walk 2 Direction	N/A
N/A	X Walk 1 Width (in)	N/A	N/A	X Walk 2 Width (in)	N/A
	X Walk 1 Slope (%)	5.6		X Walk 2 Slope (%)	N/A
	X Walk 1 X Slope (%)	10.6		X Walk 2 X Slope (%)	N/A

N/A	Ramp inside XWalk1?	N/A	N/A	Ramp inside XWalk2?	N/A
	Road Slope (%)	N/A	N/A	Clear Space?	N/A
	Road X Slope (%)	N/A	N/A	Clear Space to XWalk (in)	N/A
N/A	Any Obstructions?	N/A	N/A	Storm Grate/Utility Hazard?	N/A
	Obstruction Type			Storm Grate/Utility Type	
		N/A			N/A
			Yes	Surface Condition? (G/P)	Good

Remove & Replace Entire Ramp.

Total Cost: \$ 1850.00
