Access Compliance Report Public Rights-of-Way (Curb Ramps)

Intersection ID: 24827 Main Street: ARBORETUM_DR Cross Street: PINEVILLE-MATTHEWS_RD Location: N

ADA ID: 7B543FCBD48B Ramp Type: PerpDiag Initial Pass/Fail: Fail Overall Compliance: No Severity Score: 25

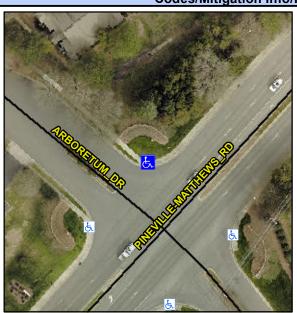
PROW/ADA: **R304.2.2**

| Compliance Description | | Data | Data Compliance Description | | Data |
|---|---|---|---|---|---|
| N/A | Ramp Length (in) | 60.0 | No | Ramp Slope (%) | 12.8 |

Remove & Replace Curb Ramp With
Two New Directional Ramps or
Equivalent.
