Access Compliance Report

Public Rights-of-Way

(Curb Ramps)

Intersection ID: 15070	Main Street: IDEAL_WY	Cross Street: REMOUNT_RD	Location: S
ADA ID: 7B5A127AE012	Ramp Type: Perp	Initial Pass/Fail: Fail	Overall Compliance: No
		Severity Score: 12.5

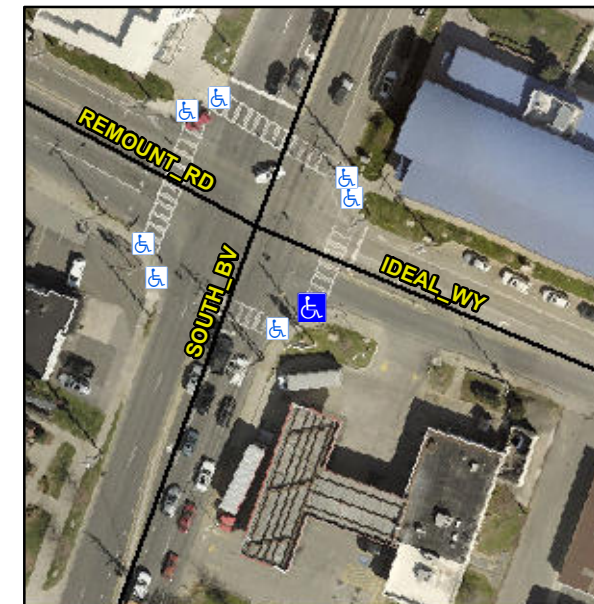
Not Found, R304.5.3

Compliance	Description	Data	Compliance	Description	Data
N/A	Ramp Length (in)	98.0	Yes	Ramp Slope (%)	6.2
Yes	Ramp Width (in)	48.0	No	Ramp XSlope (%)	6.3
N/A	Flare Type LT	N/A	N/A	Flare Type RT	N/A
N/A	Flare Slope LT (%)	N/A	N/A	Flare Slope RT (%)	N/A
N/A	Flare Traversable LT?	N/A	N/A	Flare Traversable RT?	N/A
N/A	Landing Length (in)	N/A	N/A	DWS Provided?	N/A
N/A	Landing Width (in)	N/A	N/A	DWS Contrast?	N/A
N/A	Landing Slope (%)	N/A	N/A	DWS Length (in)	N/A
N/A	Landing X Slope (%)	N/A	N/A	DWS Full Width?	N/A
N/A	Landing Curb? (Y/N)	N/A	N/A	DWS Offset (in)	N/A
N/A	Shared Landing?	N/A			
N/A	Gutter Ponding?	N/A	N/A	Gutter Slope (%)	N/A
N/A	Gutter Lip Ht (in)	N/A	N/A	Gutter X Slope (%)	N/A
N/A	Painted X Walk1?	Yes	N/A	Painted X Walk2?	N/A
	X Walk 1 Direction	To NE		X Walk 2 Direction	N/A
N/A	X Walk 1 Width (in)	112.0	N/A	X Walk 2 Width (in)	N/A
	X Walk 1 Slope (%)	3.6		X Walk 2 Slope (%)	N/A
	X Walk 1 X Slope (%)	8.5		X Walk 2 X Slope (%)	N/A

N/A	Ramp inside XWalk1?	Yes	N/A	Ramp inside XWalk2?	N/A
	Road Slope (%)	N/A	N/A	Clear Space?	N/A
	Road X Slope (%)	N/A	N/A	Clear Space to XWalk (in)	N/A
N/A	Any Obstructions?	N/A	N/A	Storm Grate/Utility Hazard?	N/A
	Obstruction Type			Storm Grate/Utility Type	
		N/A			N/A
		Yes		Surface Condition? (G/P)	Good

Remove & Replace Entire Ramp.

Total Cost: \$ 1850.00
